HARDIN COUNTY, IOWA

**ENGINEER'S
REPORT ON
REPAIR TO
LATERAL 2 OF
DRAINAGE
DISTRICT 8
HARDIN COUNTY**

Engineer's Report on Repair to Lateral 2, Drainage District 8, Hardin County, Iowa

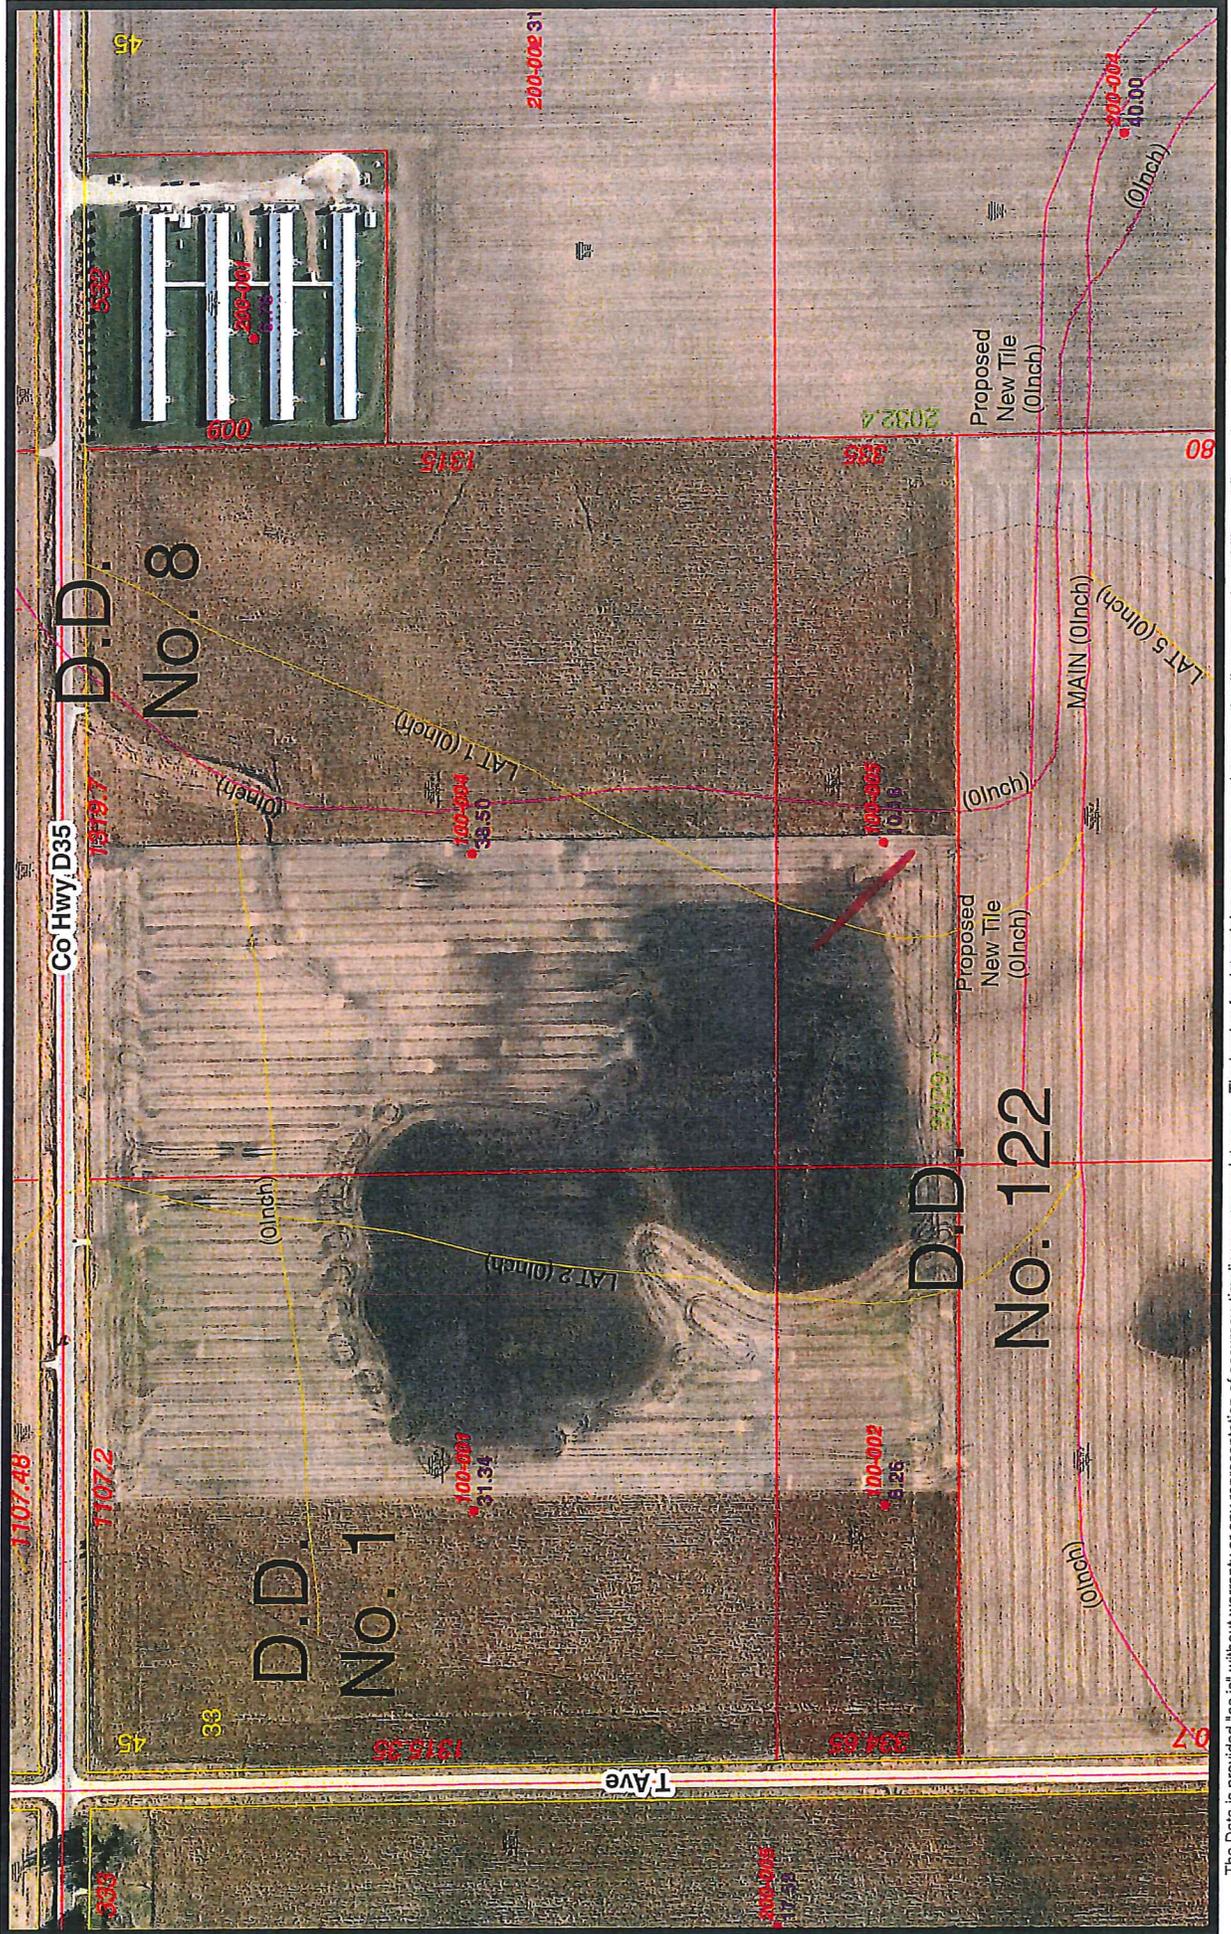
Tenant in the NW¼ of Section 30, Township 88 North, Range 19 West reported slow drainage in southeast corner of ponded area. Visually inspected area and found an intake with moving water in it, but no sign of blocked drainage. District Trustees authorized CCTV inspection and landowner requested that CCTV inspection wait until either crops are harvested or crops drowned out. Arrived on-site with contractor and landowner indicated that there is now a blowout/sinkhole visible in the field at his area of concern.

- Excavated at blowout/sinkhole and found collapsed 15" VCP lateral 2 tile near connection with main tile with slow moving water and debris (rock, silt, broken tile pieces) in flowline. Attempted to televise upstream and downstream in lateral 2 tile, but was unable to do so due to broken VCP and debris.

- Excavated at main tile and found 18" VCP main tile with slow moving water and debris (rock, silt, broken tile pieces) in flowline.
 - Televised downstream for 315'±, but was unable to continue farther due to misaligned joint.

- Attempted to televise upstream into DD 122 main tile, but was unable to do so due to broken VCP and debris.
- Per District Trustees direction, removed VCP lateral 2 tile (starting at VCP main tile and working upstream) until condition of VCP lateral 2 tile allowed televising. Removed 250'± and televised 500'± upstream in VCP lateral 2 tile, but was unable to continue farther due to debris.

- Moved upstream to just south of south right of way line of County Highway D-35, excavated and found 12" VCP lateral 2 tile.
 - Televised 460'± downstream in VCP lateral 2 tile, but was unable to continue farther due to debris.

- Attempted to televise upstream and was unable to do so due to utility cable plowed through CMP tile in south right of way of County Highway D-35. After contacting utility company, contractor removed utility line and repaired broken CMP tile with CMP band clamp (to be billed to utility company).

- Televised upstream for 315'±, but was unable to continue farther due to misaligned joint.

- The 250'± of lateral 2 tile that has been removed needs replaced. However, this length did not have a consistent grade (i.e. several 3" to 6" humps) and a straight grade between the ends of removed tile has only 2"± of fall. Therefore, additional pipe should be removed to provide adequate fall across the length of pipe already removed and to eliminate humps and sags (i.e. debris pockets) in pipe not already removed. To that end, I would recommend replacing existing

VCP lateral 2 tile from the connection with the main tile to County Highway D-35 (1400'±), which would provide 2.5'± of fall.

- The lateral 2 tile upstream of the County Highway D-35 has too much debris to be televised to determine its condition. It needs to be jet/vac cleaned and CCTV inspection performed.
- The DD 8 main tile has many cracks, but is still round except for 1 pipe length. That pipe length needs to be spot repaired.
- The DD 8 main tile has 100'± of debris just downstream of the connection with lateral 2 and needs jet/vac cleaned since much of this debris is rock and will not flush out.
- The DD 122 main tile just upstream of the connection with lateral 2 has too much debris to be televised to determine its condition. It needs to be jet/vac cleaned and CCTV inspection performed.
