**ENGINEER'S REPORT
ON REPAIR OR
IMPROVEMENTS TO
MAIN OF
DRAINAGE DISTRICT 102
HARDIN COUNTY**

Engineer's Report on Repair or Improvements to Main of Drainage District No. 102, Hardin County, Iowa

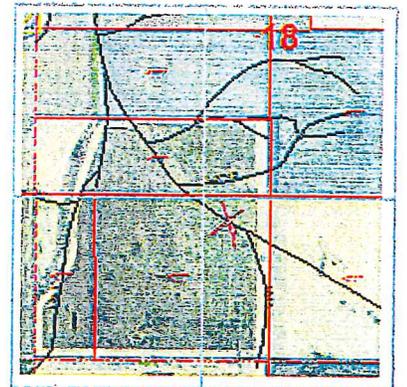
Problem Description Hole in fri SW1/4 on main tile between Lat 13 & Lat 4. It's about 3-4' wide and 3-4' deep. Possible 12" tile.

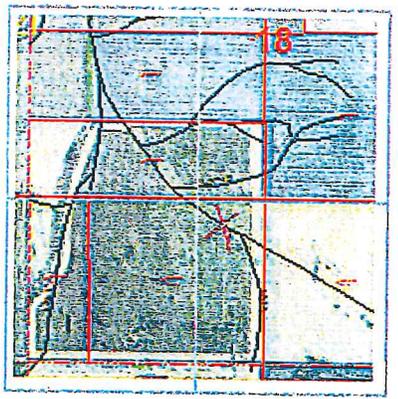
Problem Description Hole in fri SW1/4 on main tile between Lat 13 & Lat 4. It's about 3-4' wide and 3-4' deep. Possible 12" tile.

Based on this inspection and the inspection from 2015, it is obvious that the entire length of the main VCP tile is past the end of its life (in various states of collapse) and is not flowing (full of mud) for over 1800'. I would recommend total replacement of the entire length of the existing main tile. The cost would be well over \$50,000, which is high enough that a hearing and engineering report would be required for said repair.

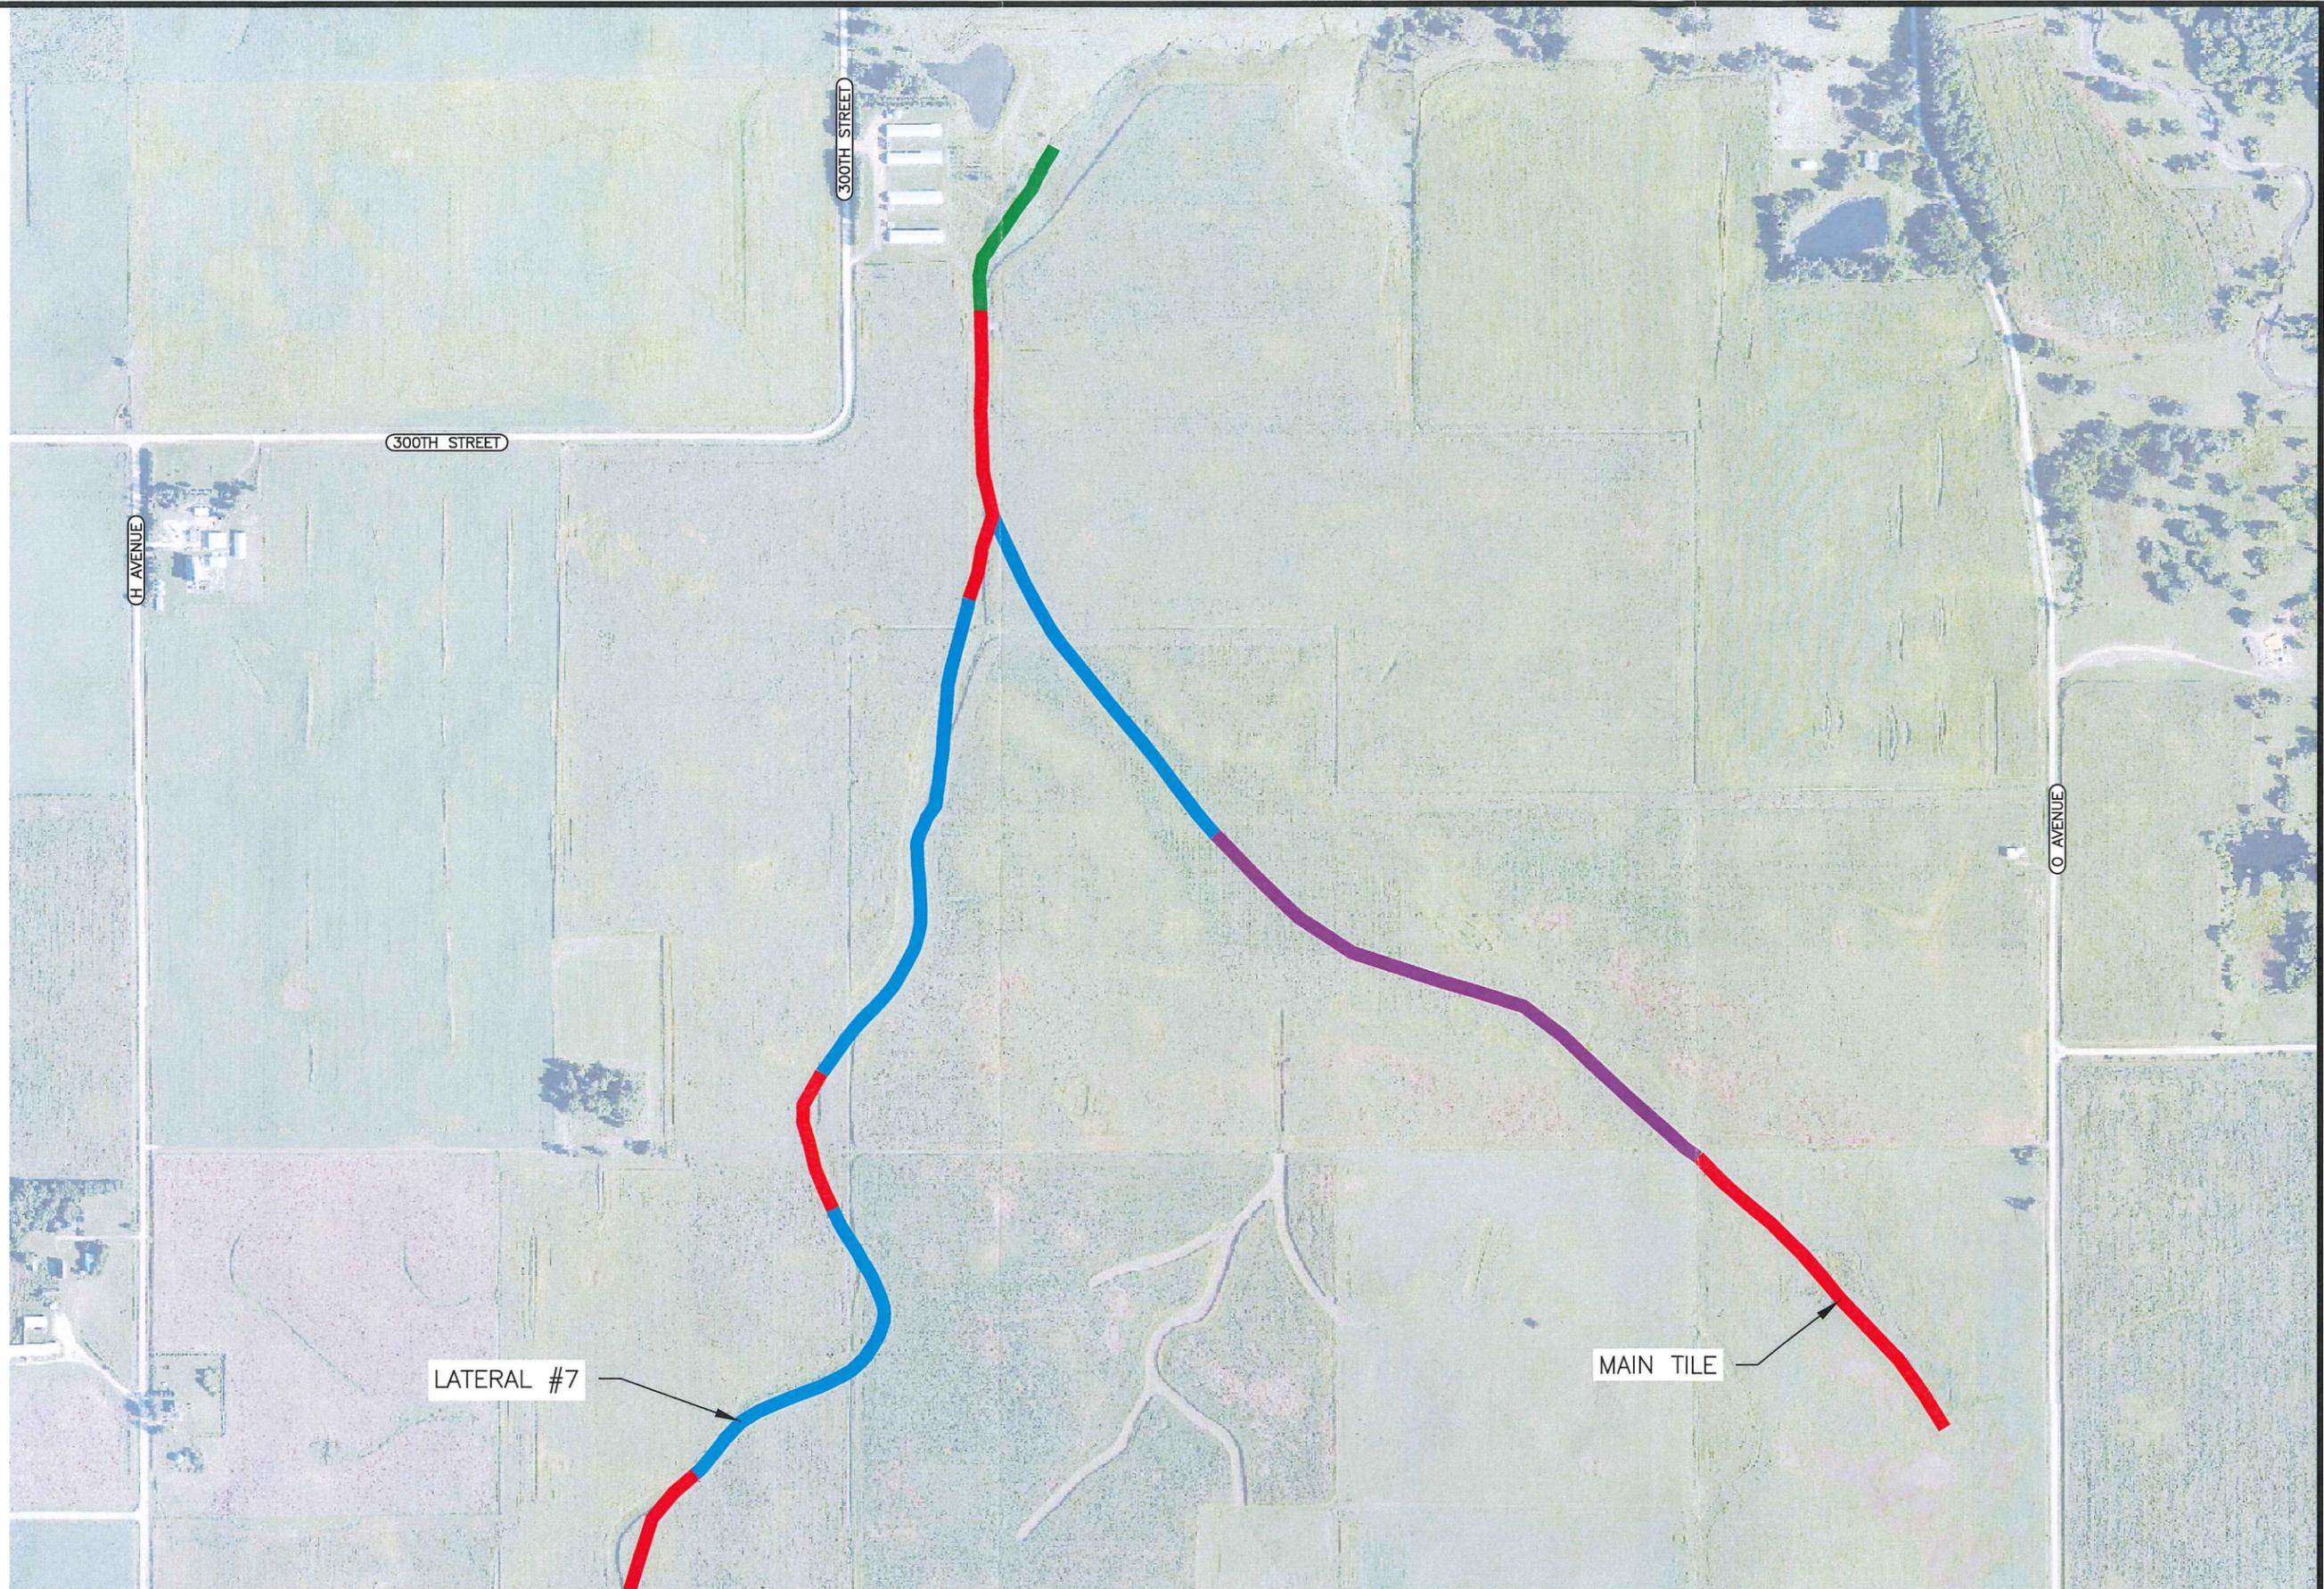
- SINKHOLES IN SURFACE ABOVE TILE
- TELEVISED TILE IN POOR CONDITION
- UNTELEVISED TILE
- PLUGGED OR COLLAPSED TILE
