**ENGINEER'S REPORT  
ON REPAIR OR  
IMPROVEMENTS TO  
LATERAL 7 TILE,  
DRAINAGE DISTRICT 102  
HARDIN COUNTY**

# Engineer's Report on Repair or Improvements to Lateral 7 Tile, Drainage District 102, Hardin County, Iowa

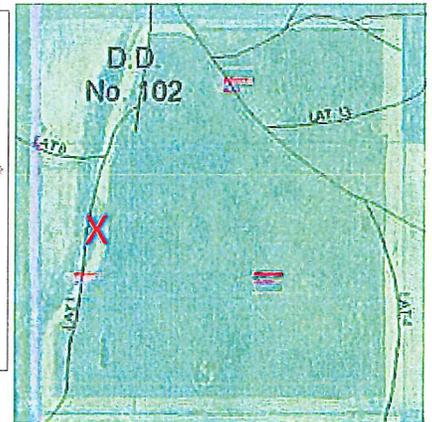
Repair Requested By Steve Perry

Problem Description Two large collapses in waterway (big enough for tractor to go through). Gehrke will be out to do work for tenant if want to coordinate work with them. Steve wants to know who is responsible for maintaining actual waterway.  
SW FRL SW Sec 18.

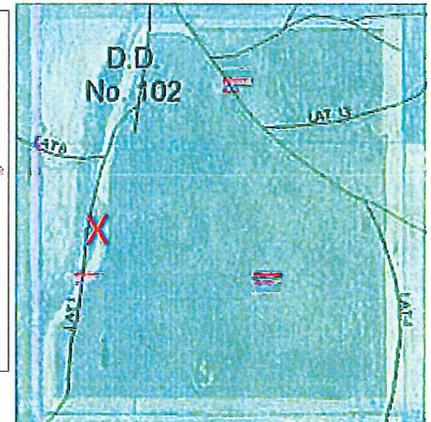
Problem Description Two large collapses in waterway (big enough for tractor to go through). Gehrke will be out to do work for tenant if want to coordinate work with them. Steve wants to know who is responsible for maintaining actual waterway. SW FRL SW Sec 18.

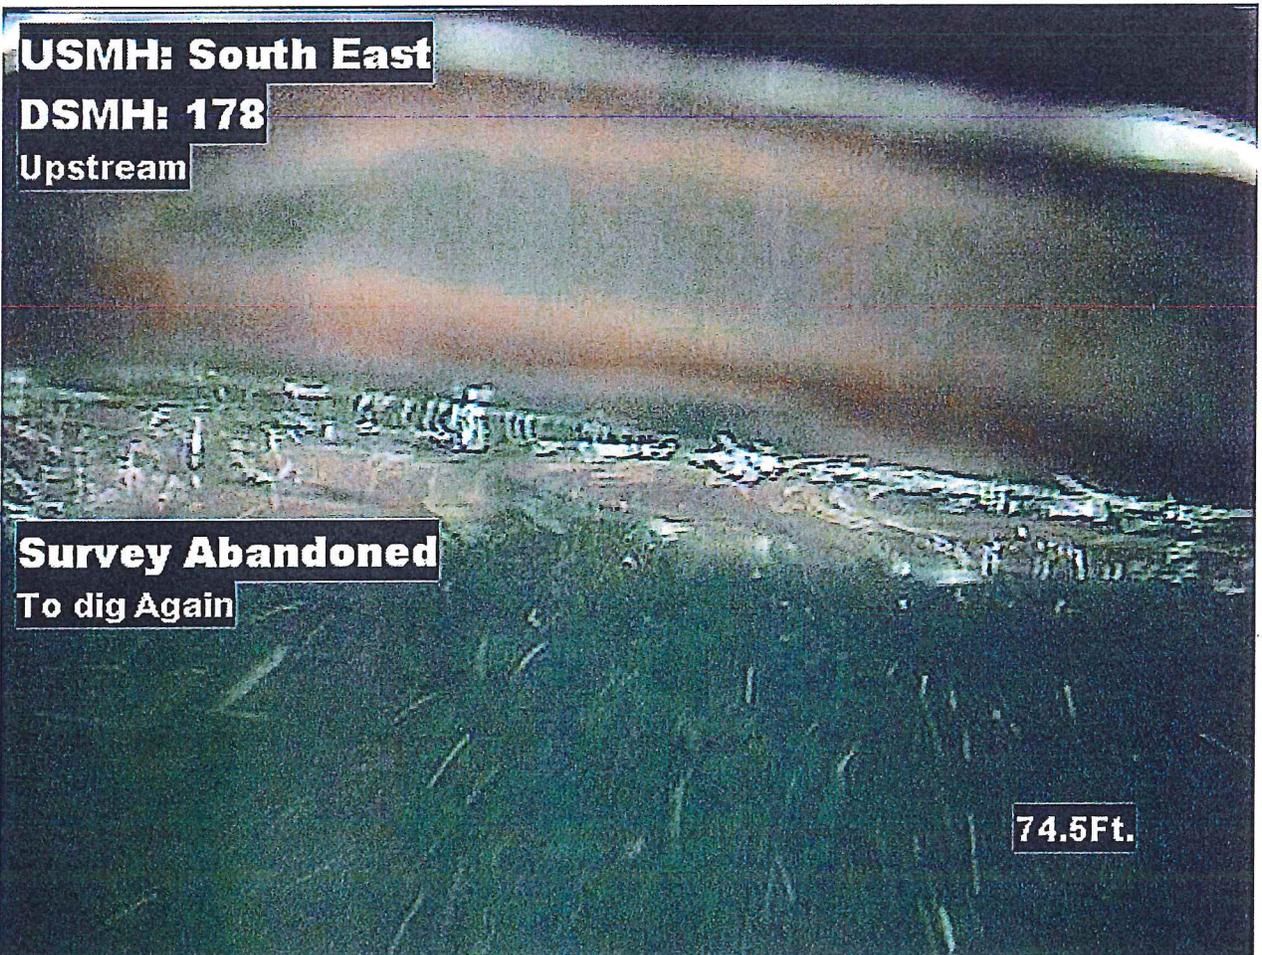
**Survey Abandoned**

**To dig Again**

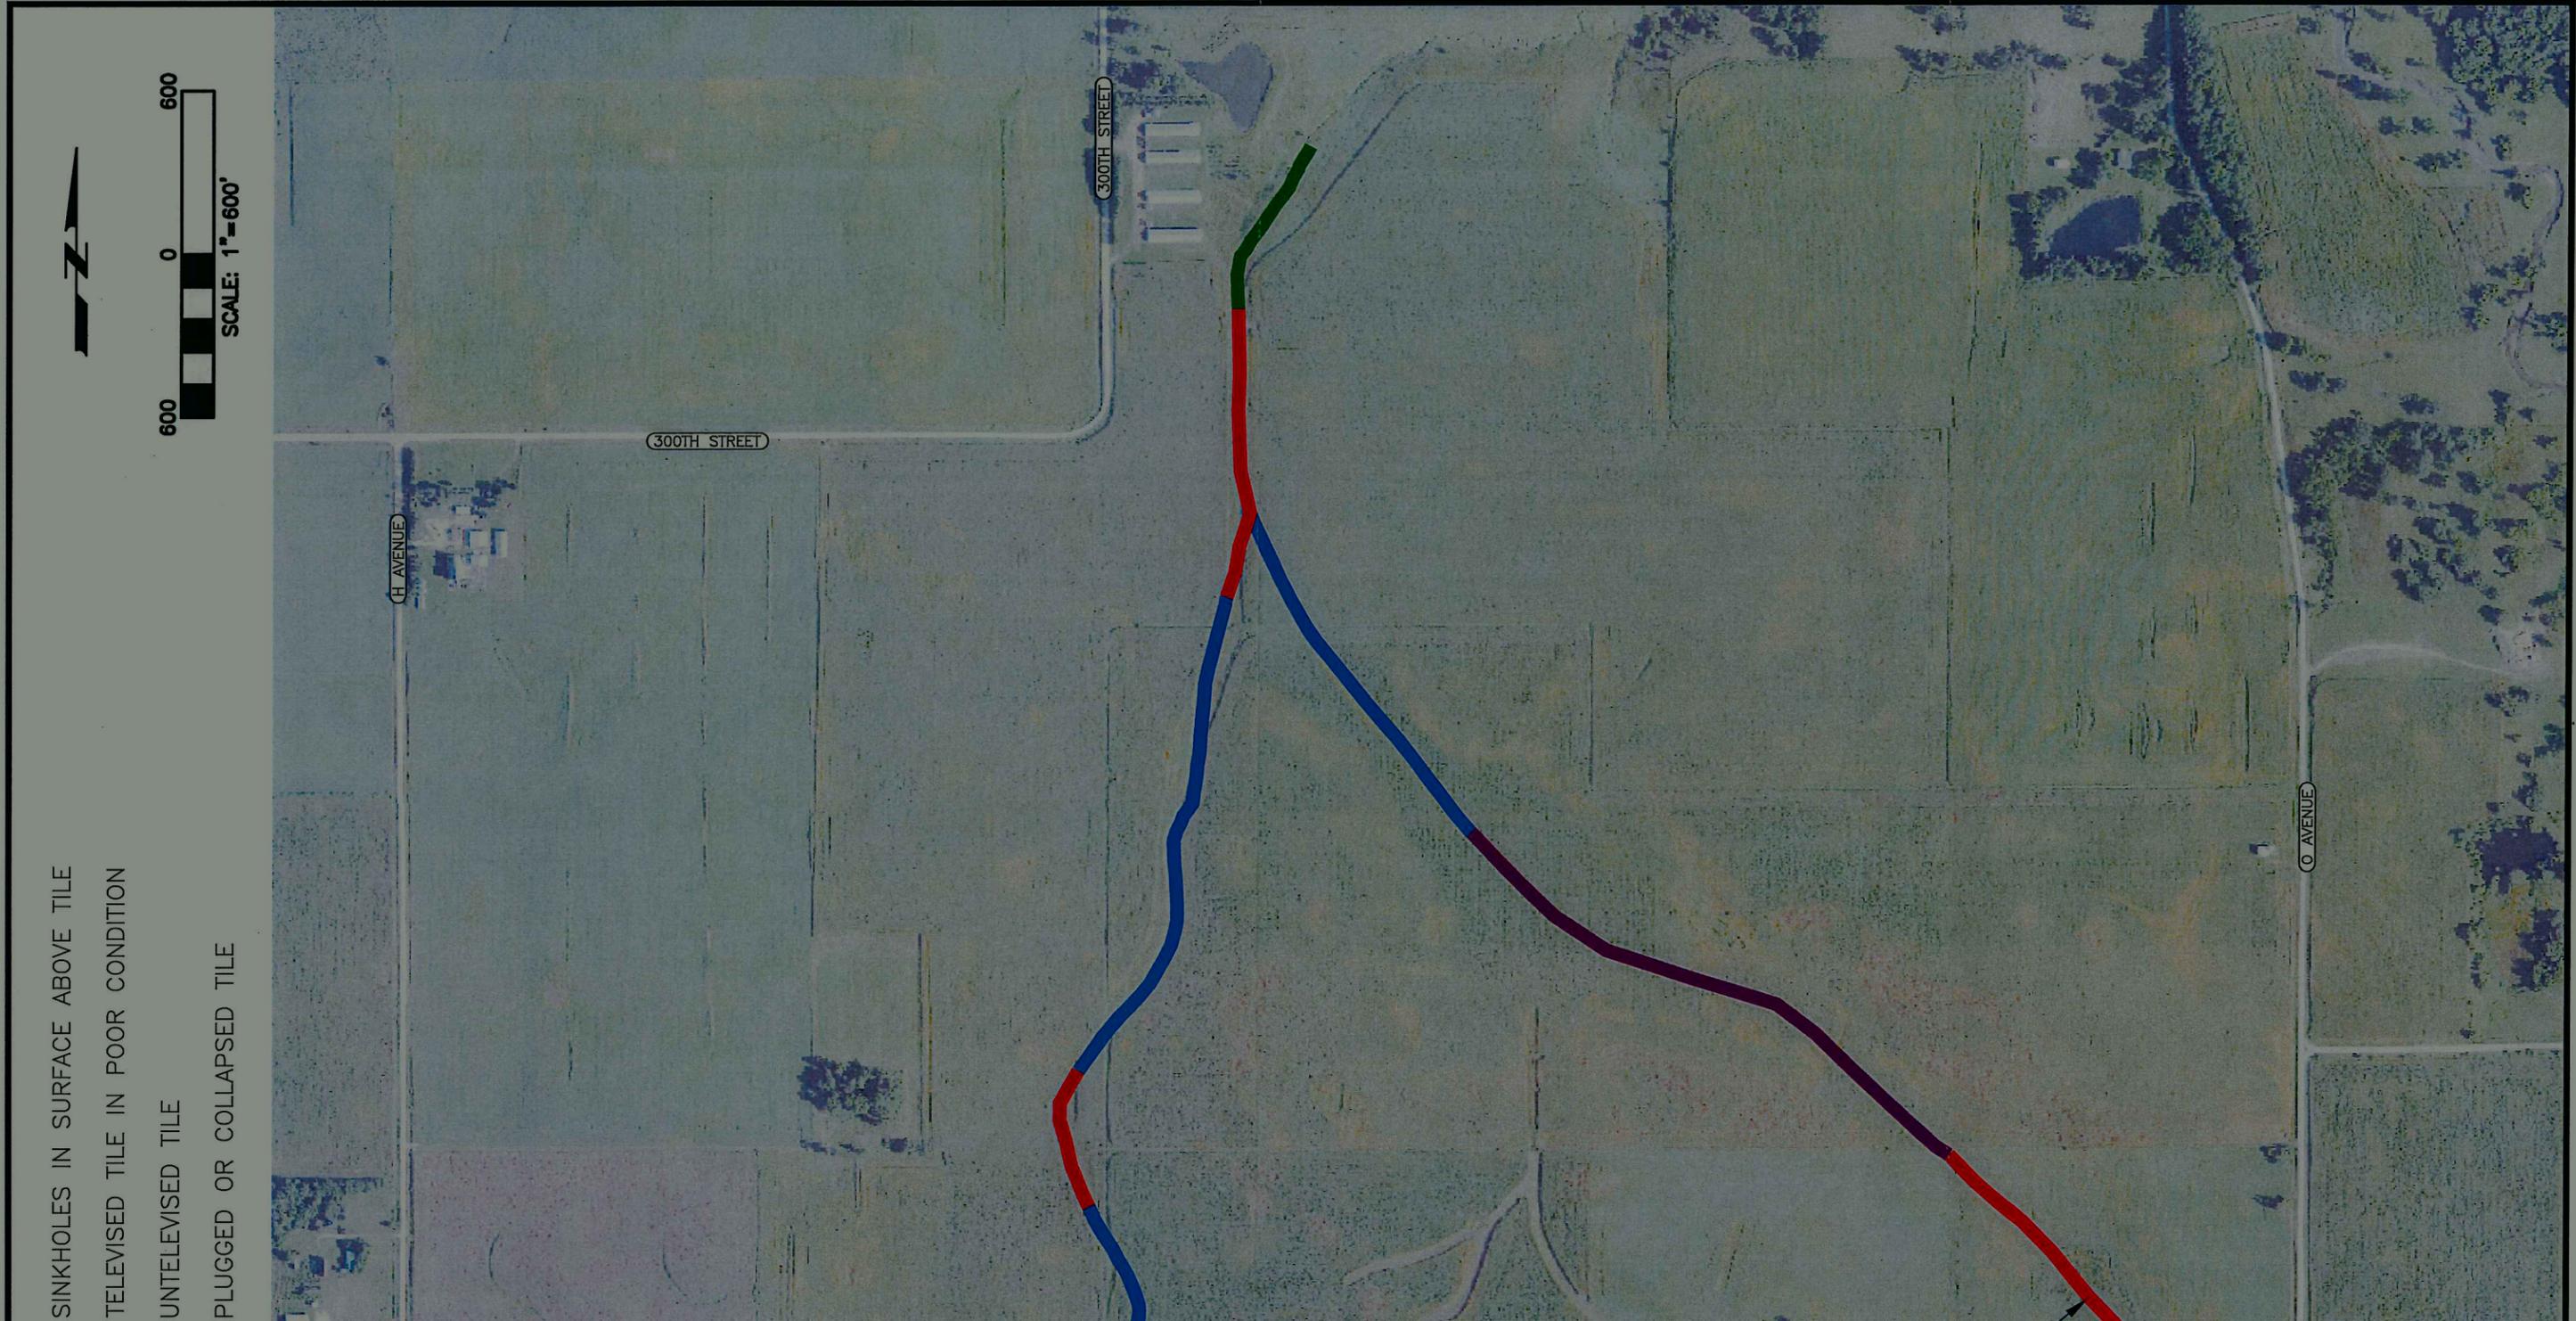
SINKHOLES IN SURFACE ABOVE TILE  
 TELEVIEWED TILE IN POOR CONDITION  
 UNTELEVIEWED TILE  
 PLUGGED OR COLLAPSED TILE
