**ENGINEER'S  
REPORT ON  
REPAIR AND  
IMPROVEMENT TO  
MAIN OF  
DRAINAGE  
DISTRICT NO. 143  
HARDIN COUNTY**

# Engineer's Report on Repair and Improvement to Main of Drainage District No. 143, Hardin County, Iowa

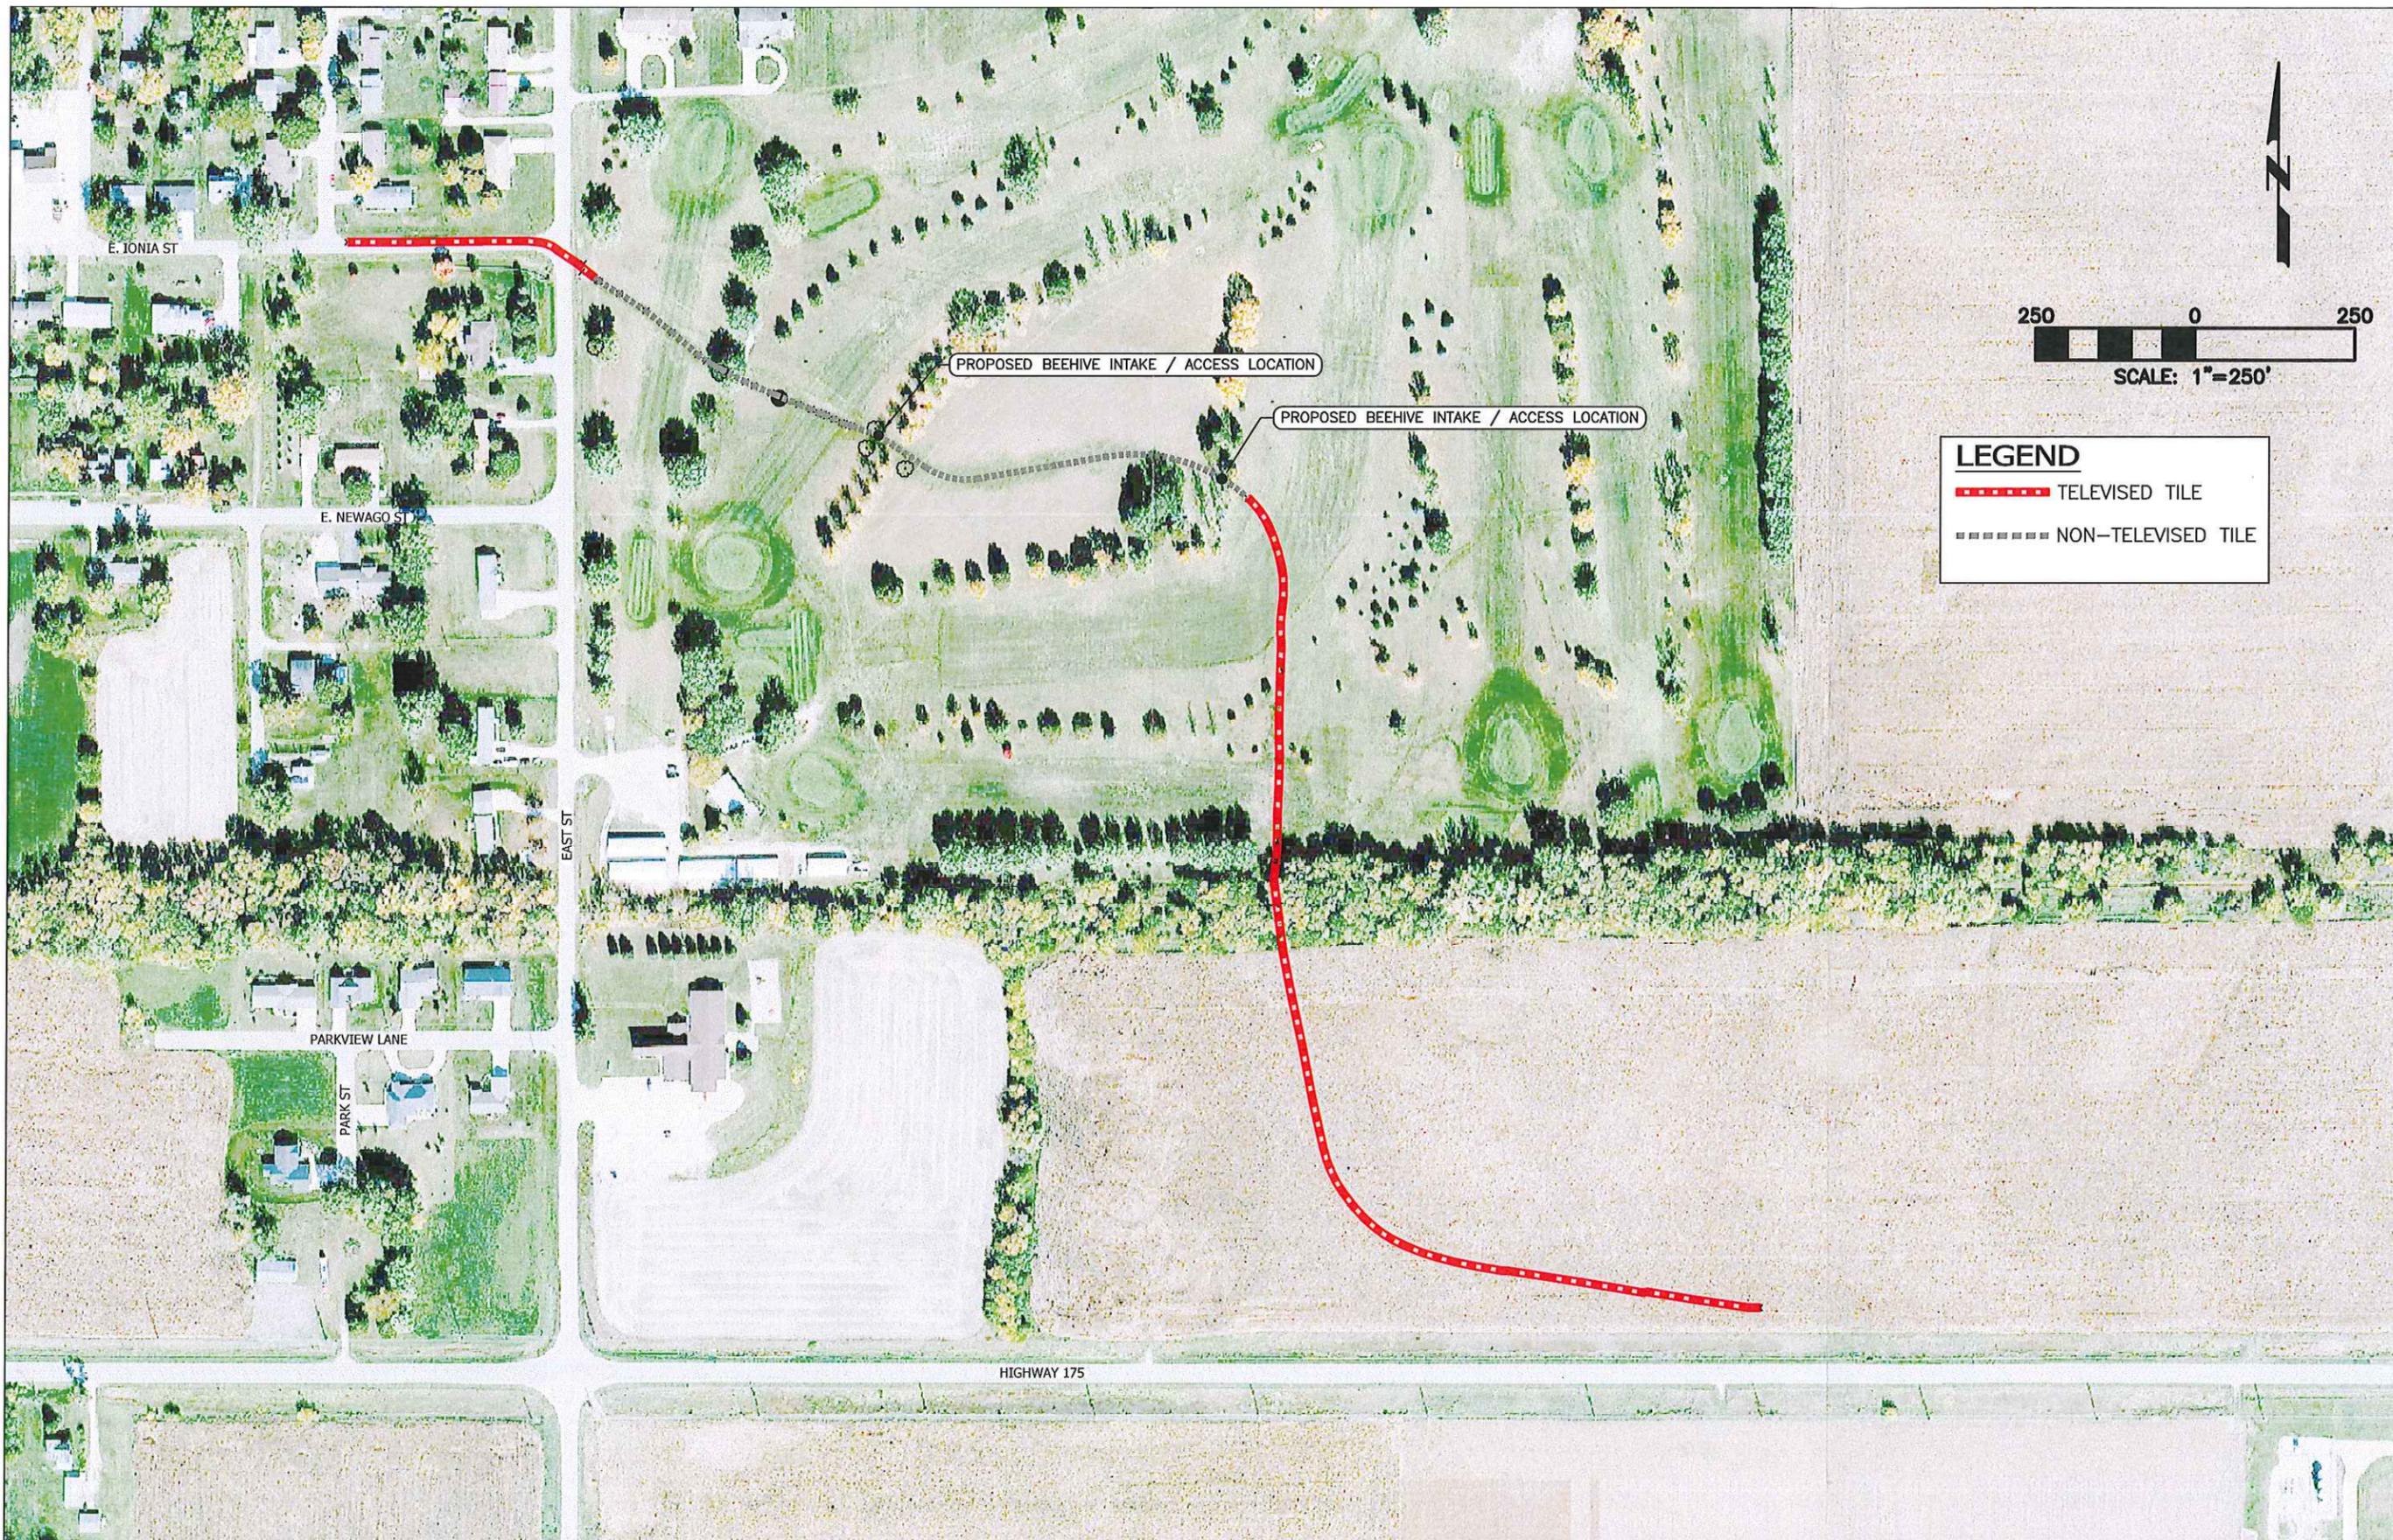
SHT. NAME:  
 DD 143 MAIN TILE  
 CLEANING AND TELEVISION

Therefore, jet cleaning and televising of the main tile was attempted on two different dates from the intake just east of County Highway S-27 (west side of golf course). Initially the main tile was full of water that wasn't flowing, but after jet cleaning the water started to flow slowly. Even with jet cleaning, no televising could be performed downstream at this location due to the large amount of silt in the pipe and the slow moving water. However, televising was performed 400 feet upstream from this location and the main tile appeared to be in good condition as it headed west under Ionia Street. There were only 3 areas that contained broken pipe or pipe in disrepair and both of those were under County Highway S-27. For reference, the Cleaning and Televising map showing these limits is included at the end of Appendix A.

In addition, jet cleaning and televising of the main tile was attempted on two different dates from the intake just north of the former railroad (south side of golf course). There was a small amount of water flowing in the tile, but initially the main tile couldn't be televised upstream to the northwest as there were too many tree roots. After jet cleaning, televising was performed upstream for 600 feet. The main tile appeared to be in poor condition in this area with 3 pipe lengths that were broken and ready to collapse. In addition, there were 4 previous repairs evident with single wall or rusted CMP. Finally, televising could not proceed past 600 feet upstream as there were roots encountered that were large enough that the CCTV equipment could not get past them and jet cleaning could not cut them. Televising was performed for 1200 feet downstream without any problems and the main tile appeared to be in average condition with 6 pipe lengths that were broken and ready to collapse. For reference, the Cleaning and Televising map showing these limits is included at the end of Appendix A.

- Clean and televise entire main tile through golf course, which will be difficult as access to the tile is currently restricted. Therefore, intakes/access locations need to be installed at tree lines in golf course (see attached drawing).
- Water jet and vacuum clean silt from main tile, cut roots in main tile, and re-televise main tile to determine permanent course of action (lining, replacement or pipe bursting). Main tile can't be relocated as golf course has indicated there are many private tiles connected to it.
- Estimated cost of above work (not including permanent course of action) is \$10,000.
