**ENGINEER'S REPORT  
ON IMPROVEMENTS TO  
MAIN TILE OF  
DRAINAGE DISTRICT 25  
HARDIN COUNTY**

# Engineer's Report on Improvements to Main Tile of Drainage District No. 25, Hardin County, Iowa

PROJECT: DRAINAGE DISTRICT #25  
 HARDIN COUNTY, IOWA  
 2016

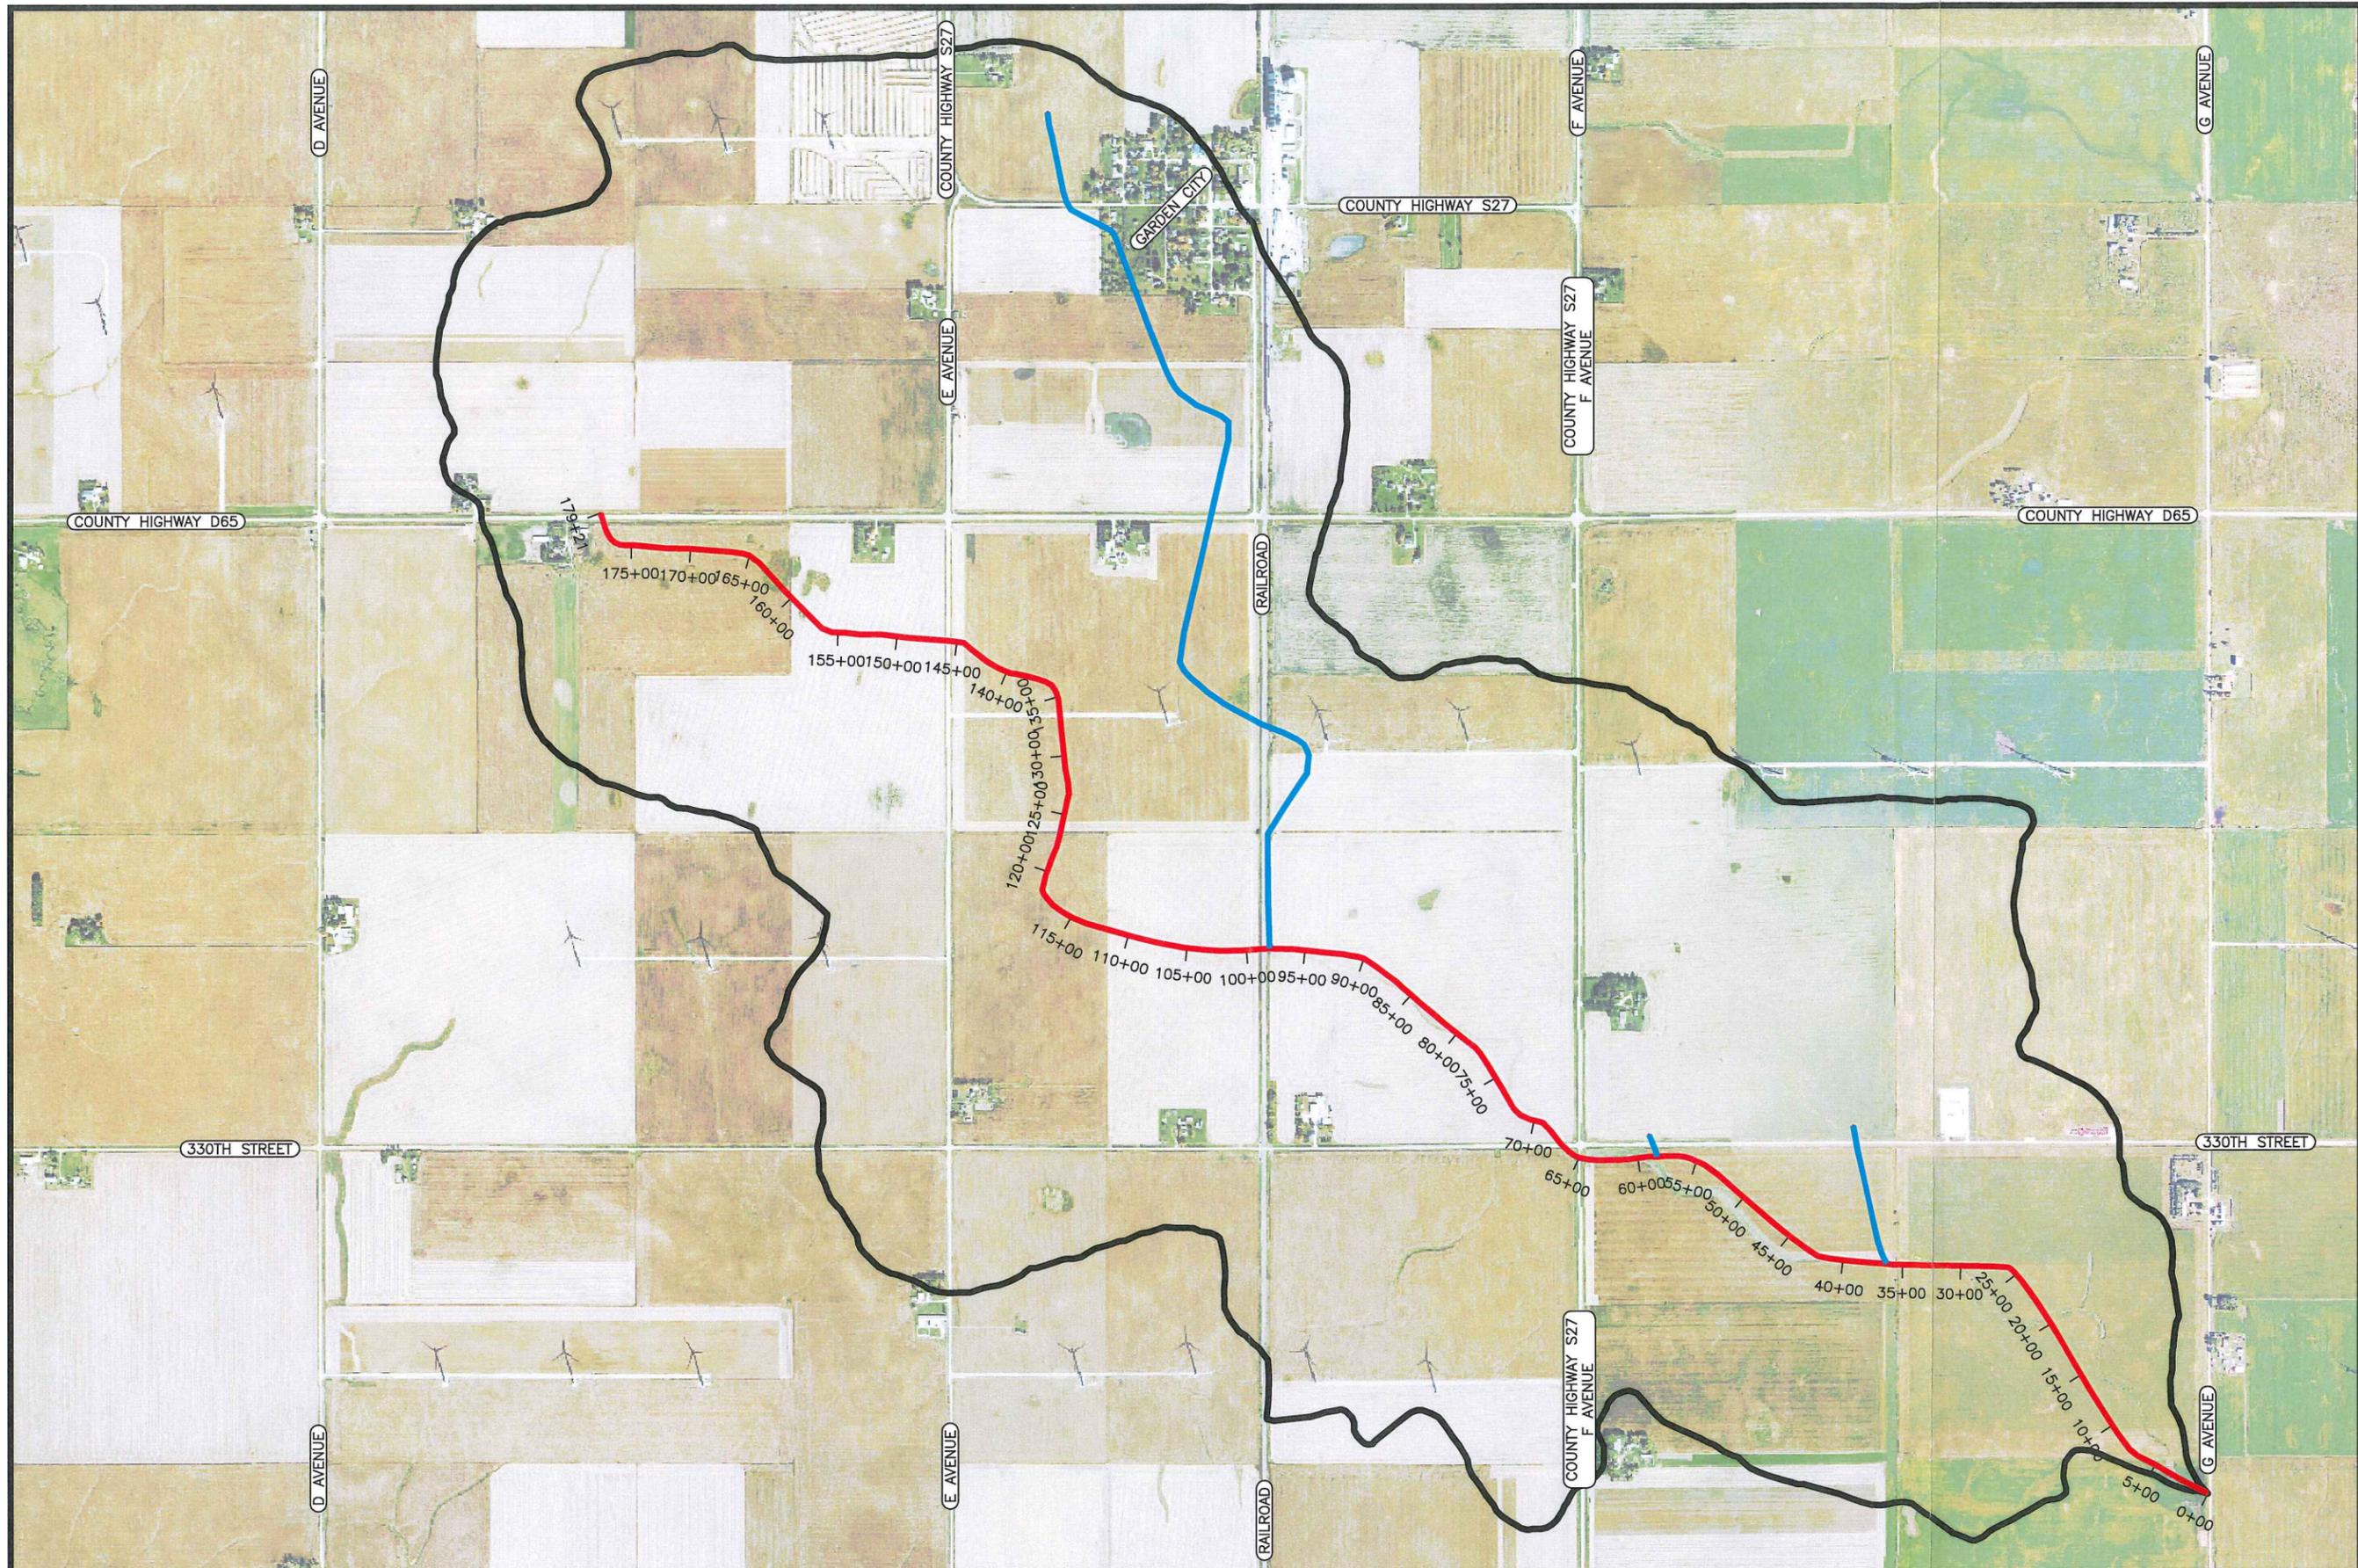
SHEET NAME: LOCATION MAP OF IMPROVEMENTS

— EXISTING LATERAL TILE  
— EXISTING MAIN TILE TO BE IMPROVED
