**ENGINEER'S REPORT  
ON REPAIR OR  
IMPROVEMENT TO  
LATERAL 9 AND 9C  
TILES, DIVISION 3,  
DRAINAGE DISTRICT 55  
HARDIN COUNTY**

**RYKEN**  
ENGINEERING & LAND SURVEYING, INC.

**Engineer's Report on Repair or Improvement to  
Lateral 9 and 9C Tiles,  
Division 3, Drainage District 55, Hardin County, Iowa**

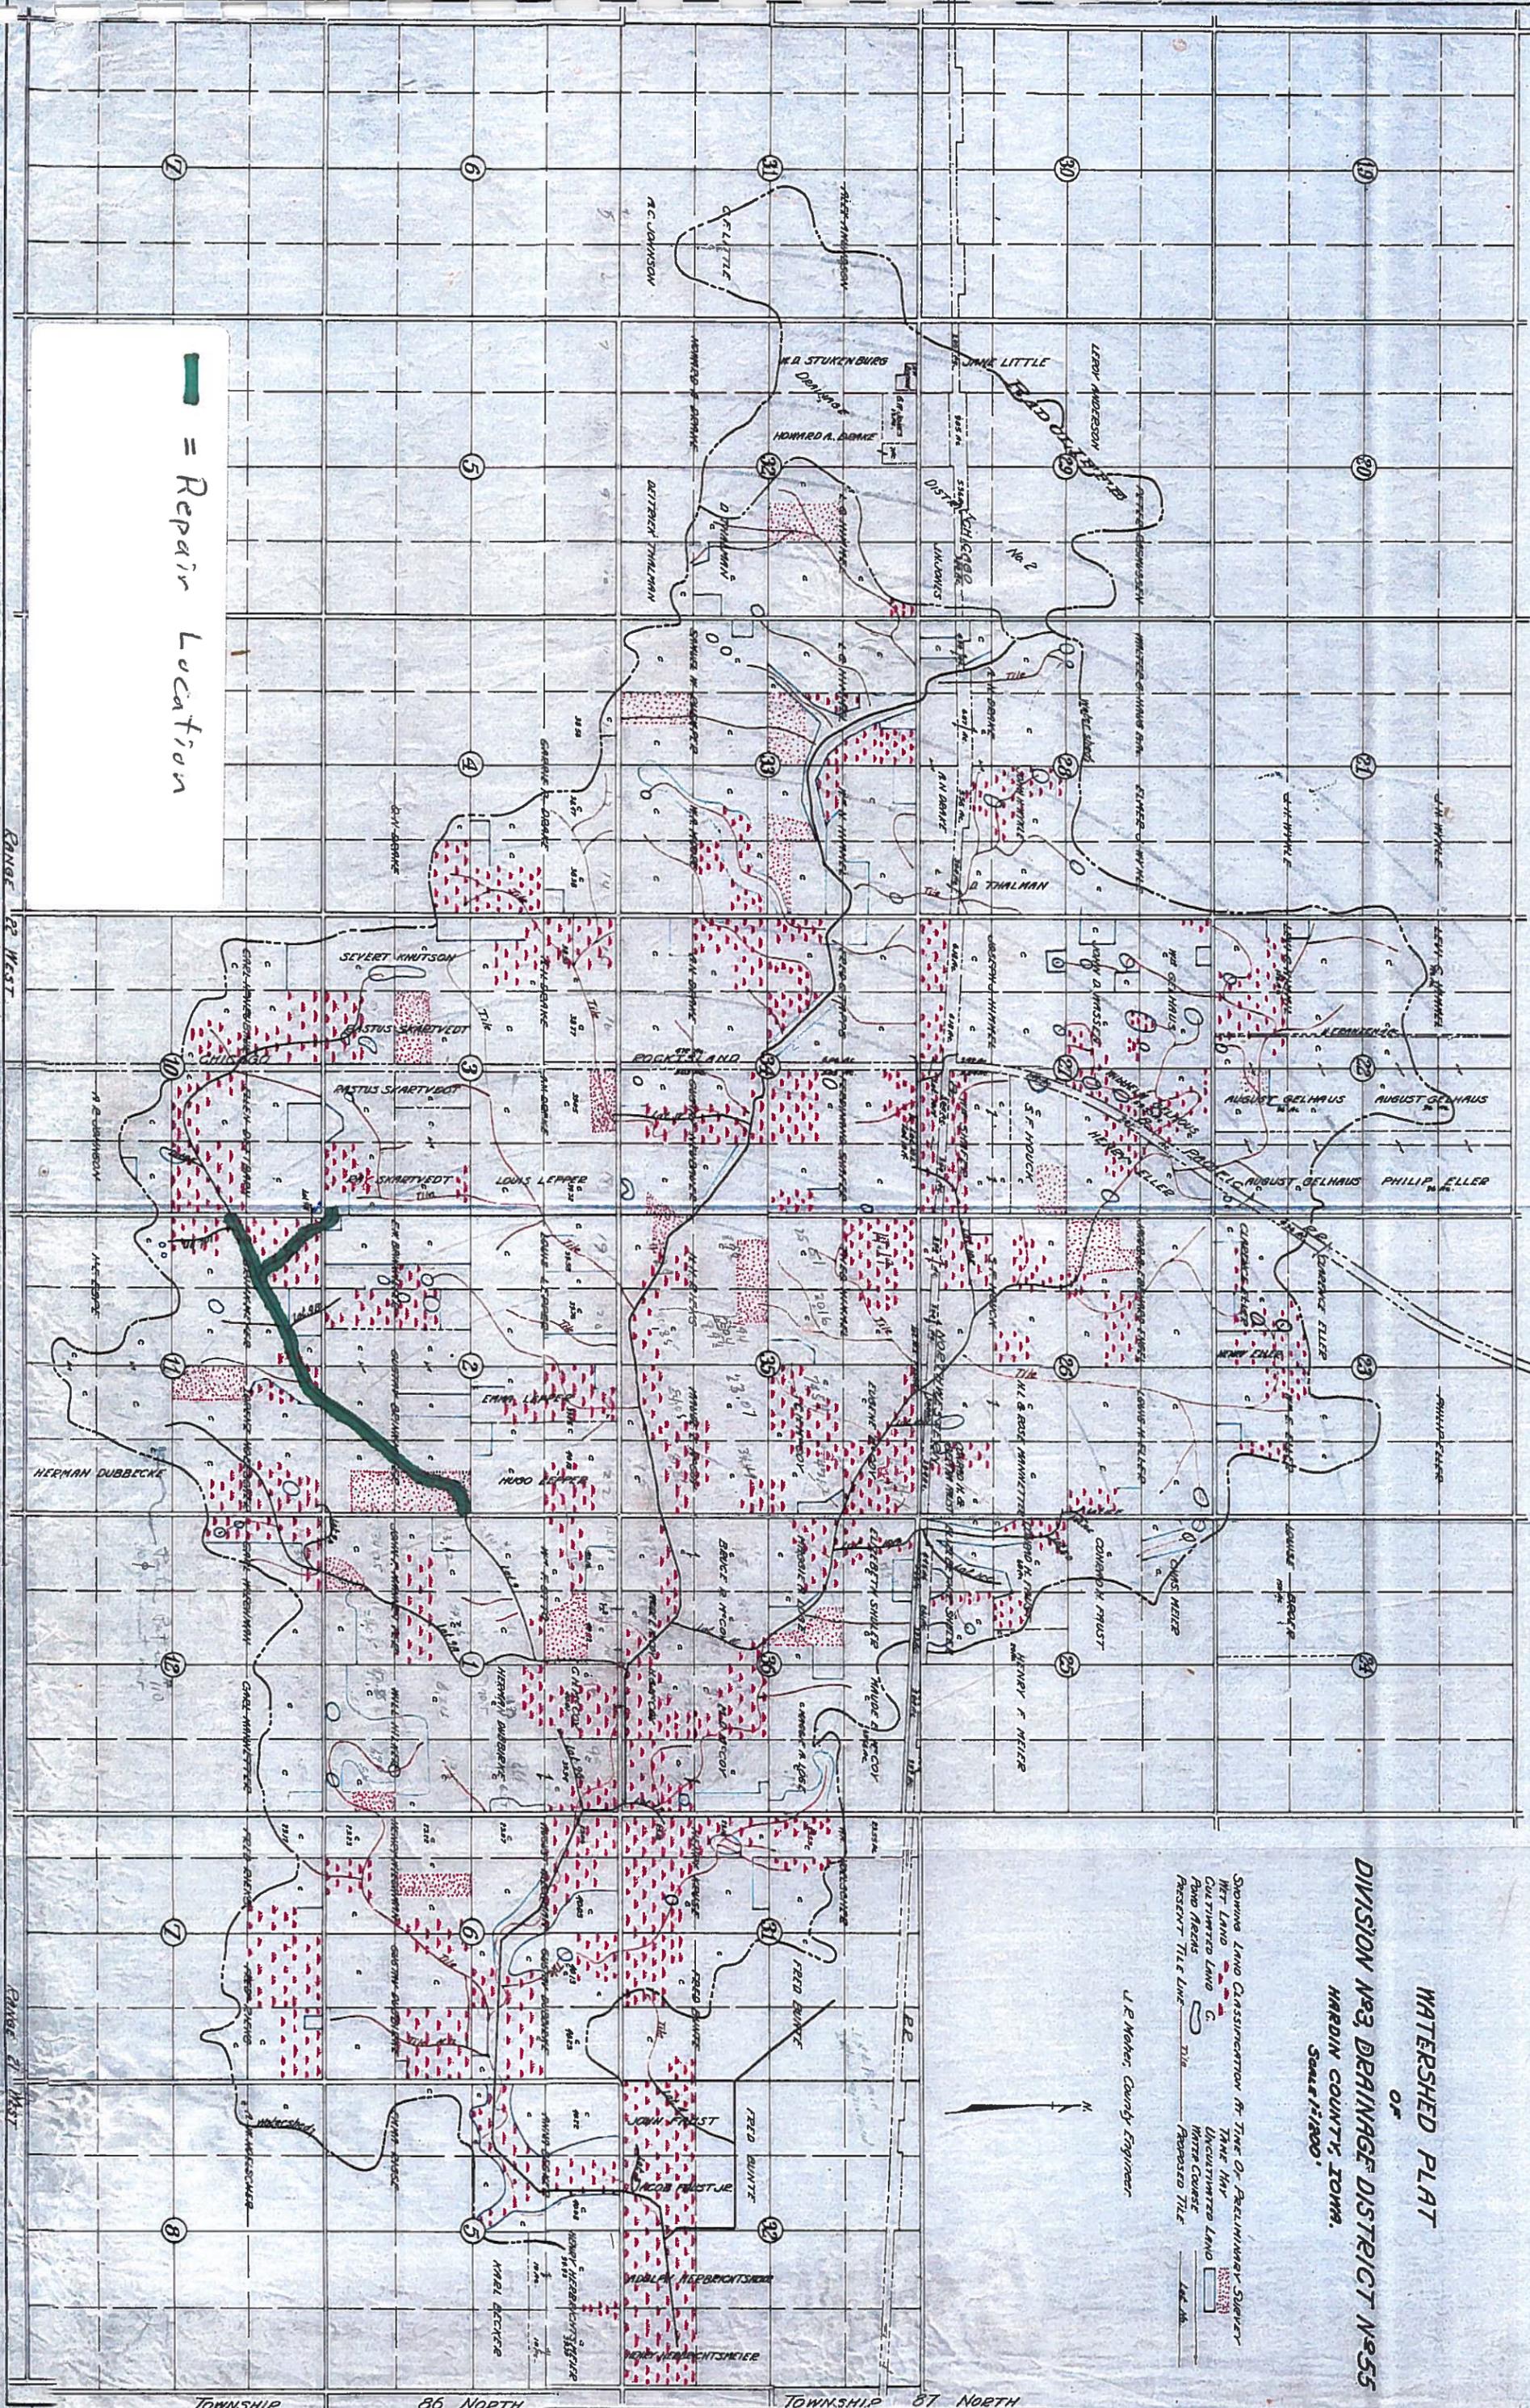
**█ = Repair Location**

- 5 locations that have been replaced with HDPE tile.
- 1 location that has a broken VCP tile or a soil void visible above the tile.
- Interior of the pipe in severely deteriorated condition (evidenced by spalled pipe interior, multiple cracks, partially collapsed pipe along entire tile route, and tile collapsed on camera while televising).
- Restricted flow through a large majority of the televised tile (evidenced by pieces of broken tile, rocks, mud, and silt in the tile and uneven water levels throughout the televising).

- 2 locations that have been replaced with HDPE tile.
- 1 location that has a broken VCP tile and a soil void visible above the tile.
- Interior of the pipe in severely deteriorated condition (evidenced by spalled pipe interior, multiple cracks, and partially collapsed pipe along entire tile route).
- Restricted flow through a large majority of the televised tile (evidenced by pieces of broken tile, rocks, mud, and silt in the pipe and uneven water levels throughout the televising).

VCP tile on these laterals is past the end of its useful life. This is evidenced by the above investigation and the fact that neither the contractor excavating for the televising or our firm has ever seen a VCP tile in such a fragile state. Although some repairs have been made, they are few and far between. This provides only an occasional length of stable pipe linked together by VCP that has either failed or is in imminent danger of failure. Therefore, the tile will only continue to collapse which will lead to the creation of sinkholes. As a result, further siltation in the tile and blockage of the tile with tile pieces and soil will occur, further restricting drainage.

5.0 REPAIR METHOD – To repair the above discussed issue, the most straightforward method is to replace the existing Lateral 9 and 9C tiles in the same corridor, drainage pattern, and size (nearest currently manufactured) that they currently use. Given the severe condition of the tile and its shallowness, this replacement would be for the entire length of the tile and would be with reinforced concrete pipe for both laterals (copy of map showing repair locations included in Appendix D).

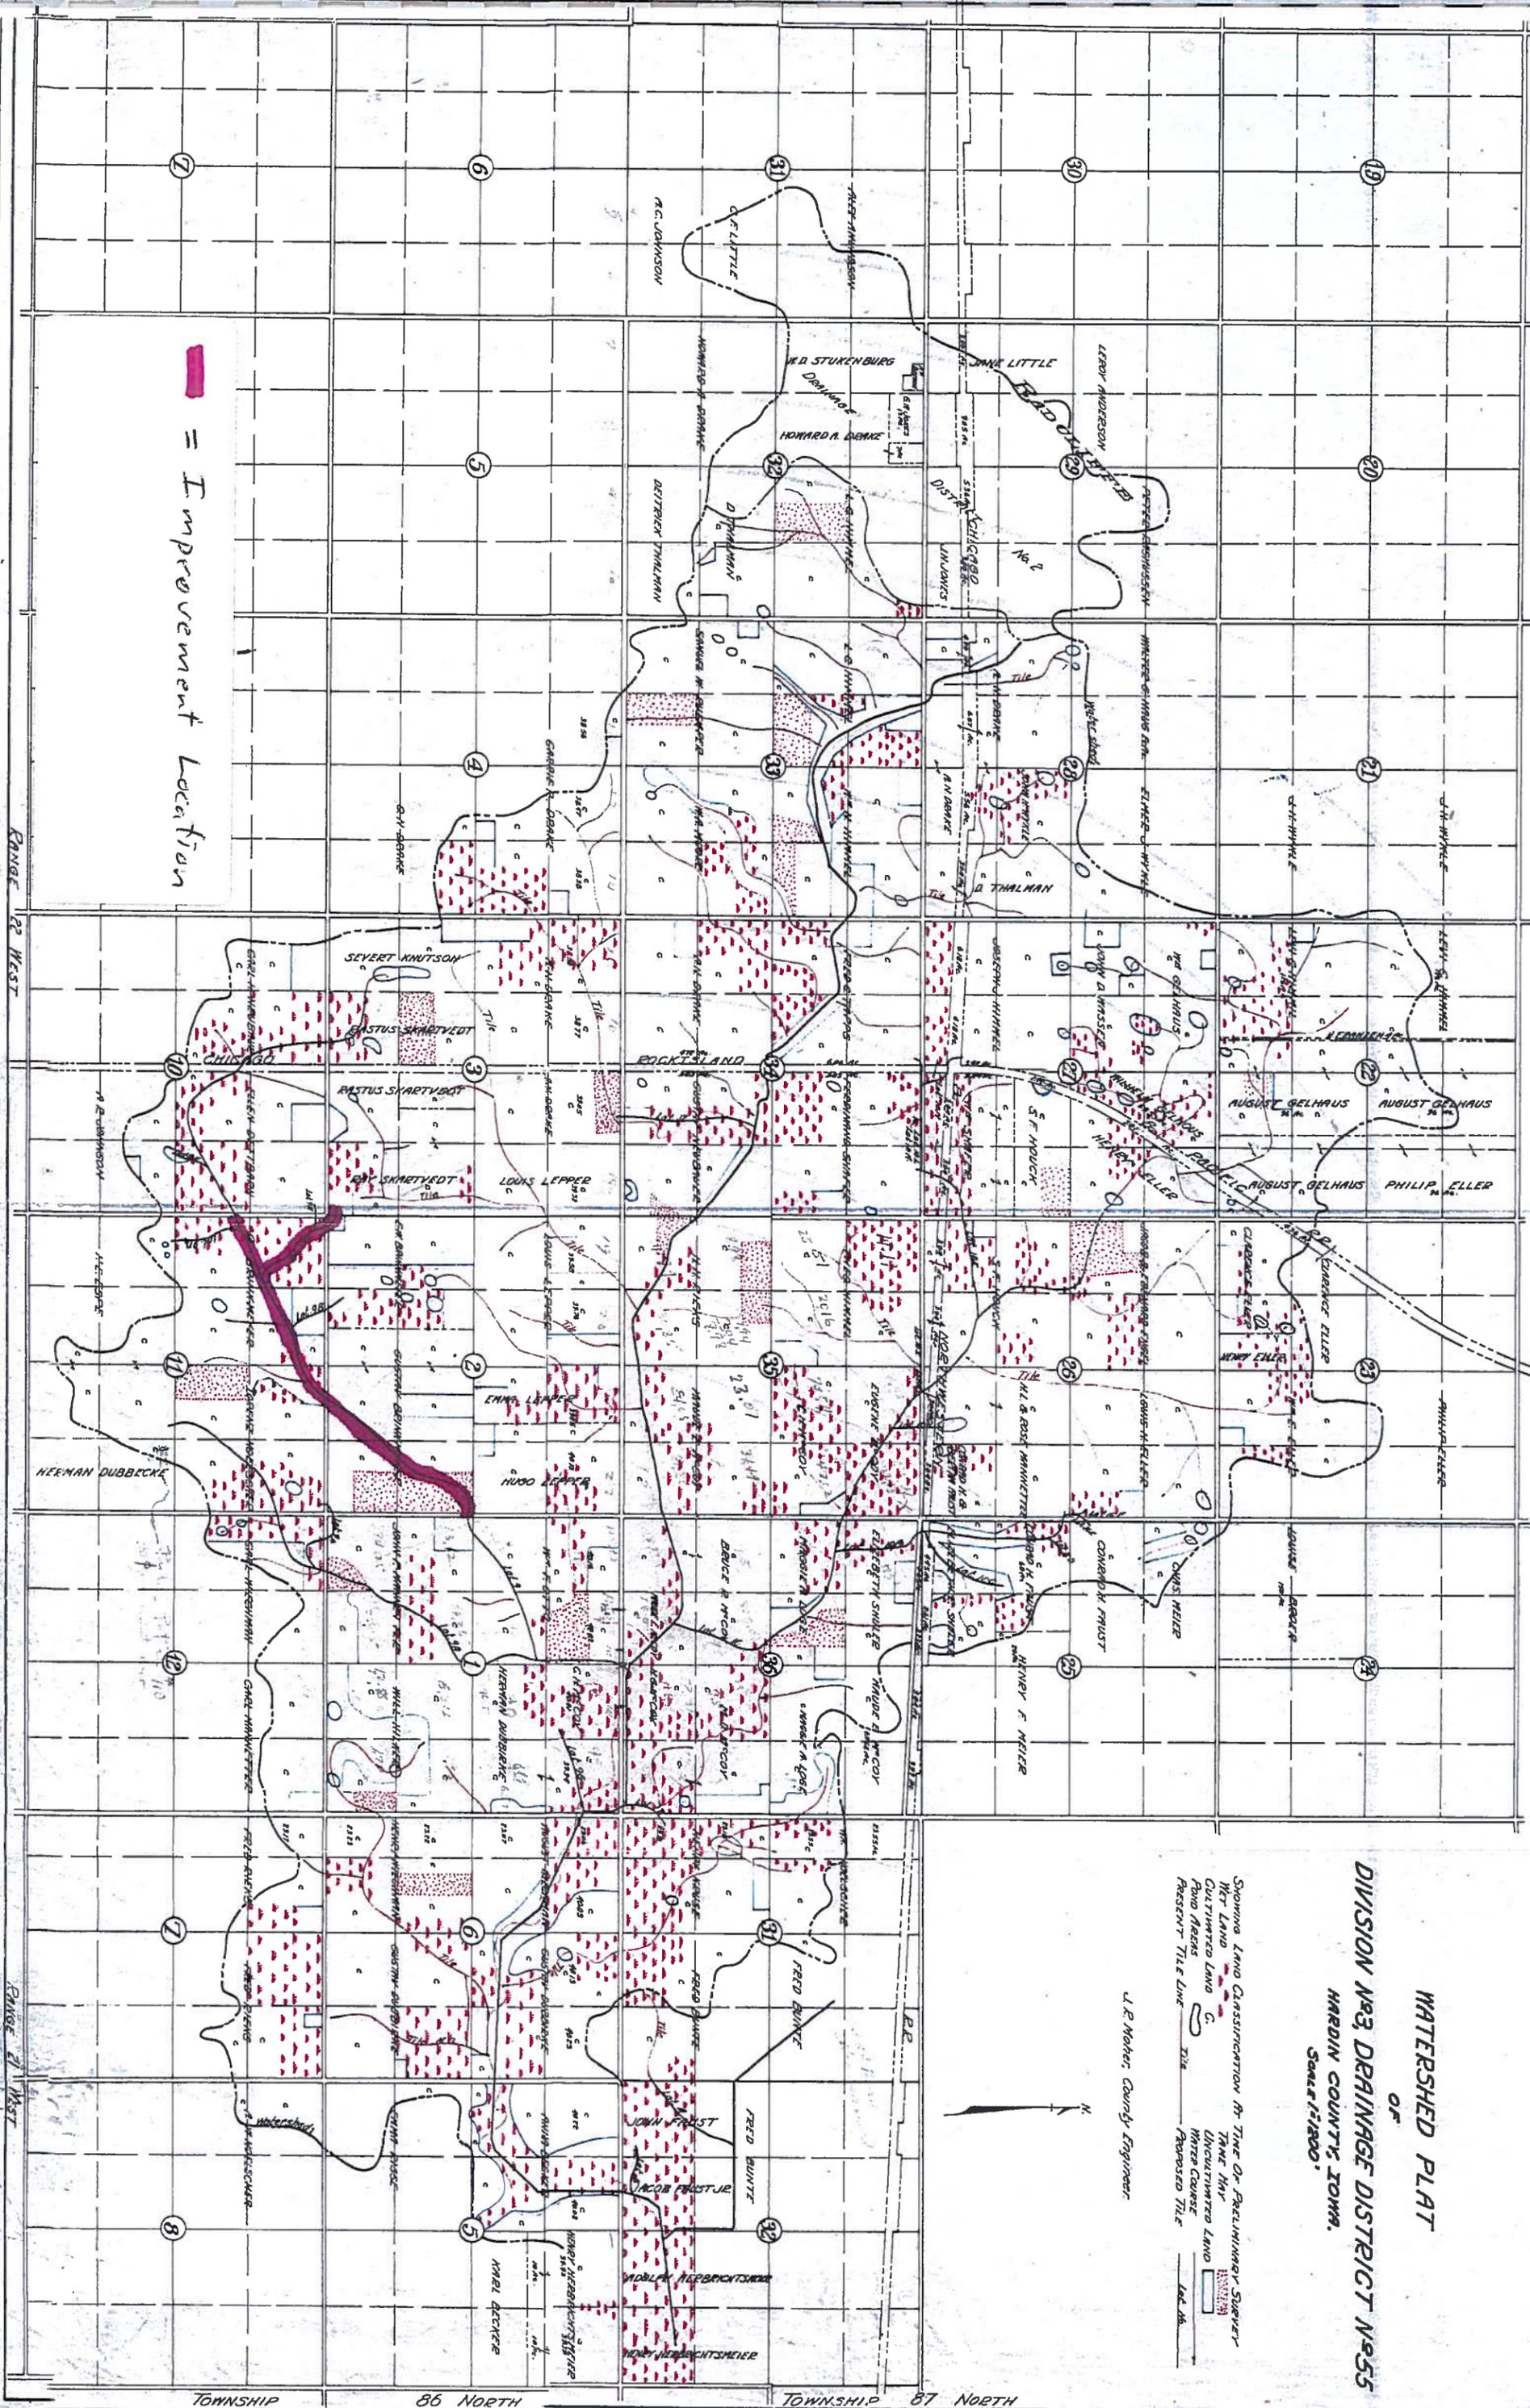
= Improvement Location

It should be noted that the existing tile is adequate to drain approximately 70 acres using the standard 1/2" per acre per day drainage coefficient. A quick review of the record drainage area reveals that this tile serves closer to 700 acres. Since so much of the tile needs replacement, if an improvement (upsizing a tile) is desired, this is probably the time.

6.0 IMPROVEMENT METHODS – To improve drainage for the above discussed areas, the most straightforward method is to replace the existing Lateral 9 and 9C tiles in the same corridor and drainage pattern, but increase the size of the tile that they currently use. Given the severe condition of the tile and its shallowness, this upsizing would be for the entire length of the tile and would be with reinforced concrete pipe for both laterals (copy of map showing improvement locations included in Appendix E).
