**ENGINEER'S REPORT
ON REPAIR OR
IMPROVEMENTS TO
MAIN OF
DRAINAGE DISTRICT 102
HARDIN COUNTY**

Engineer's Report on Repair or Improvements to Main of Drainage District No. 102, Hardin County, Iowa

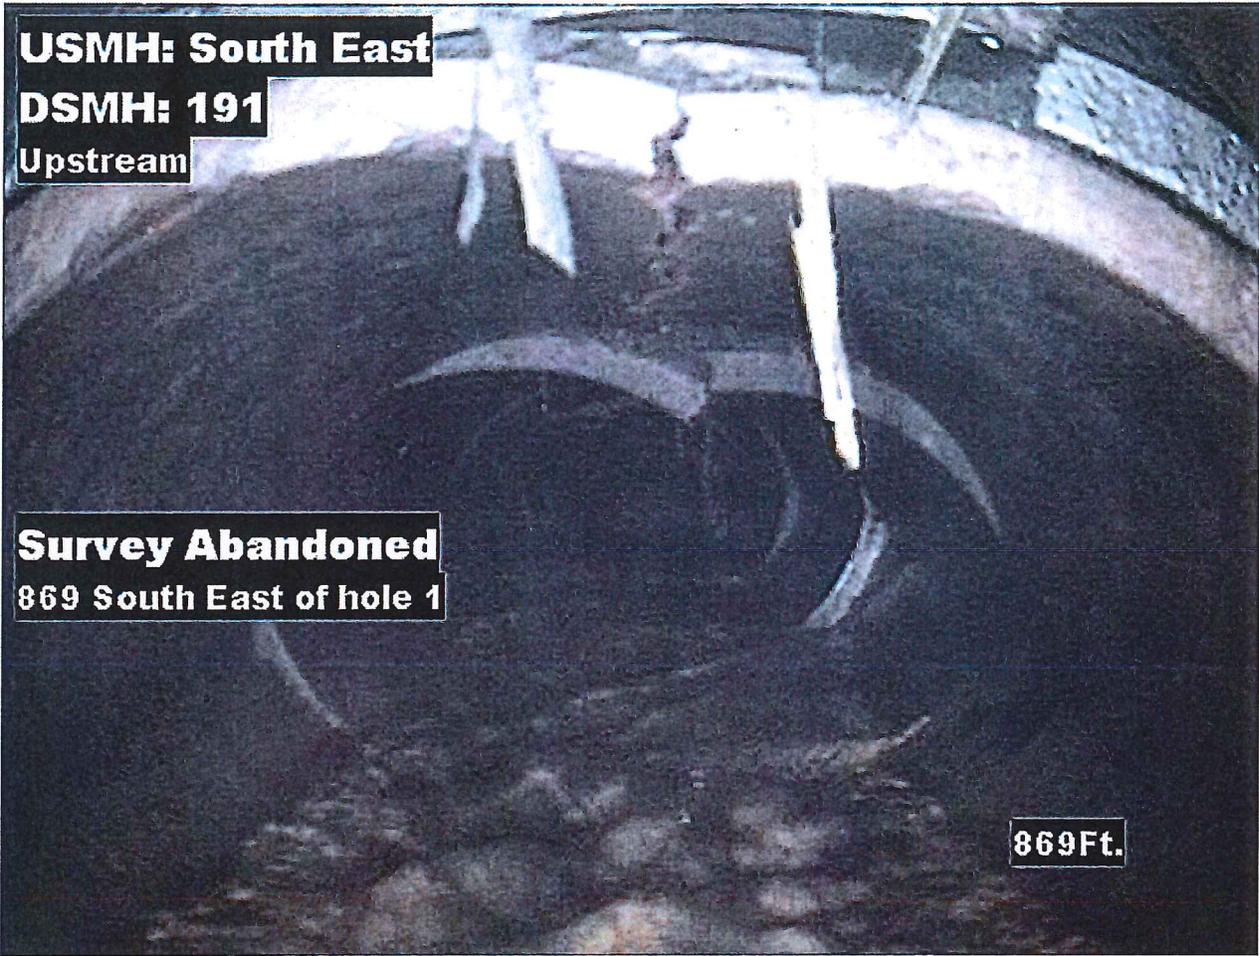
869 South East of hole 1

Based on this inspection and the inspection from 2015, it is obvious that the entire length of the main VCP tile is past the end of its life (in various states of collapse) and is not flowing (full of mud) for over 1800'. I would recommend total replacement of the entire length of the existing main tile. The cost would be well over \$50,000, which is high enough that a hearing and engineering report would be required for said repair.
