**ENGINEER'S  
REPORT ON  
REPAIR AND  
IMPROVEMENT TO  
MAIN OF  
DRAINAGE  
DISTRICT NO. 143  
HARDIN COUNTY**

# Engineer's Report on Repair and Improvement to Main of Drainage District No. 143, Hardin County, Iowa

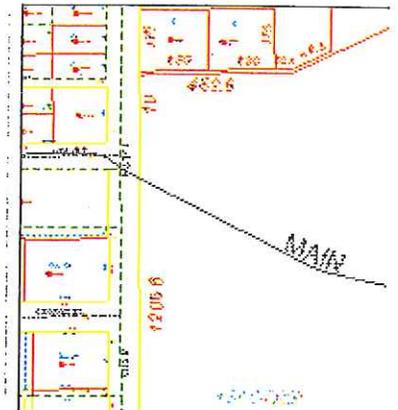
Problem Description See Letter (Restriction in main on East side of Radcliffe about 600' East of Hwy S27 under golf course.)

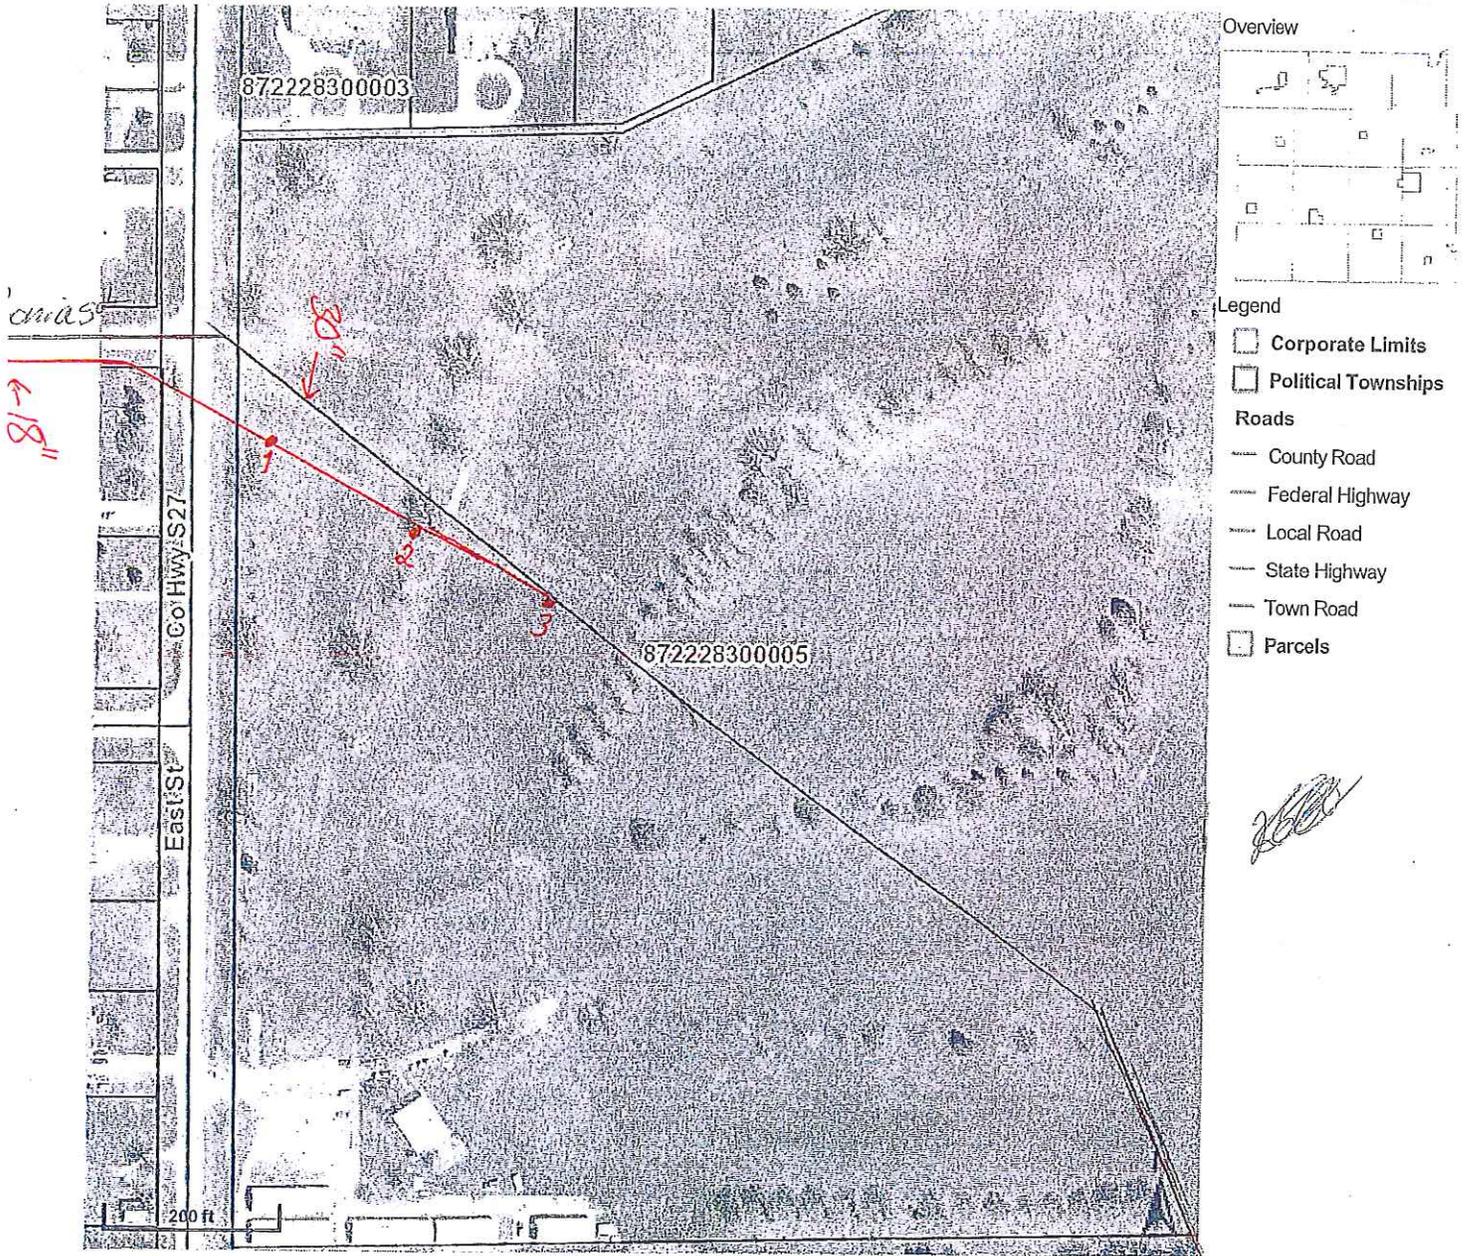
1. The City put in a 8" Cleanout in last summer to continue setting east.
2. Its believed to be Pugged with tree roots.
3. I were the 18" tile connects with the 30" main, unknown location
