**ENGINEER'S REPORT  
ON REPAIR OR  
IMPROVEMENT TO  
LATERAL 9 AND 9C  
TILES, DIVISION 3,  
DRAINAGE DISTRICT 55  
HARDIN COUNTY**

**RYKEN**  
ENGINEERING & LAND SURVEYING, INC.

**Engineer's Report on Repair or Improvement to  
Lateral 9 and 9C Tiles,  
Division 3, Drainage District 55, Hardin County, Iowa**

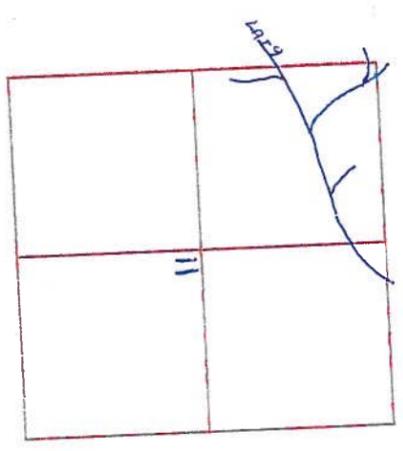
Problem Description Tile crumbling

labor, materials and equipment 2 1/2 hrs Trench mini EXCAVATOR OPERATOR + 1 LABORER

12" HDPE, 11.2' OF 10" HDPE, 45' OF 8" HDPE, 6' OF 6" HDPE, FABRIC @ TRENCH
