ENGINEER'S REPORT ON REPAIR AND IMPROVEMENT TO EXISTING MAIN TILE OF DRAINAGE DISTRICT 98 HARDIN COUNTY

Engineer's Report on Repair and Improvement to Existing Main Tile of Drainage District 98, Hardin County, Iowa

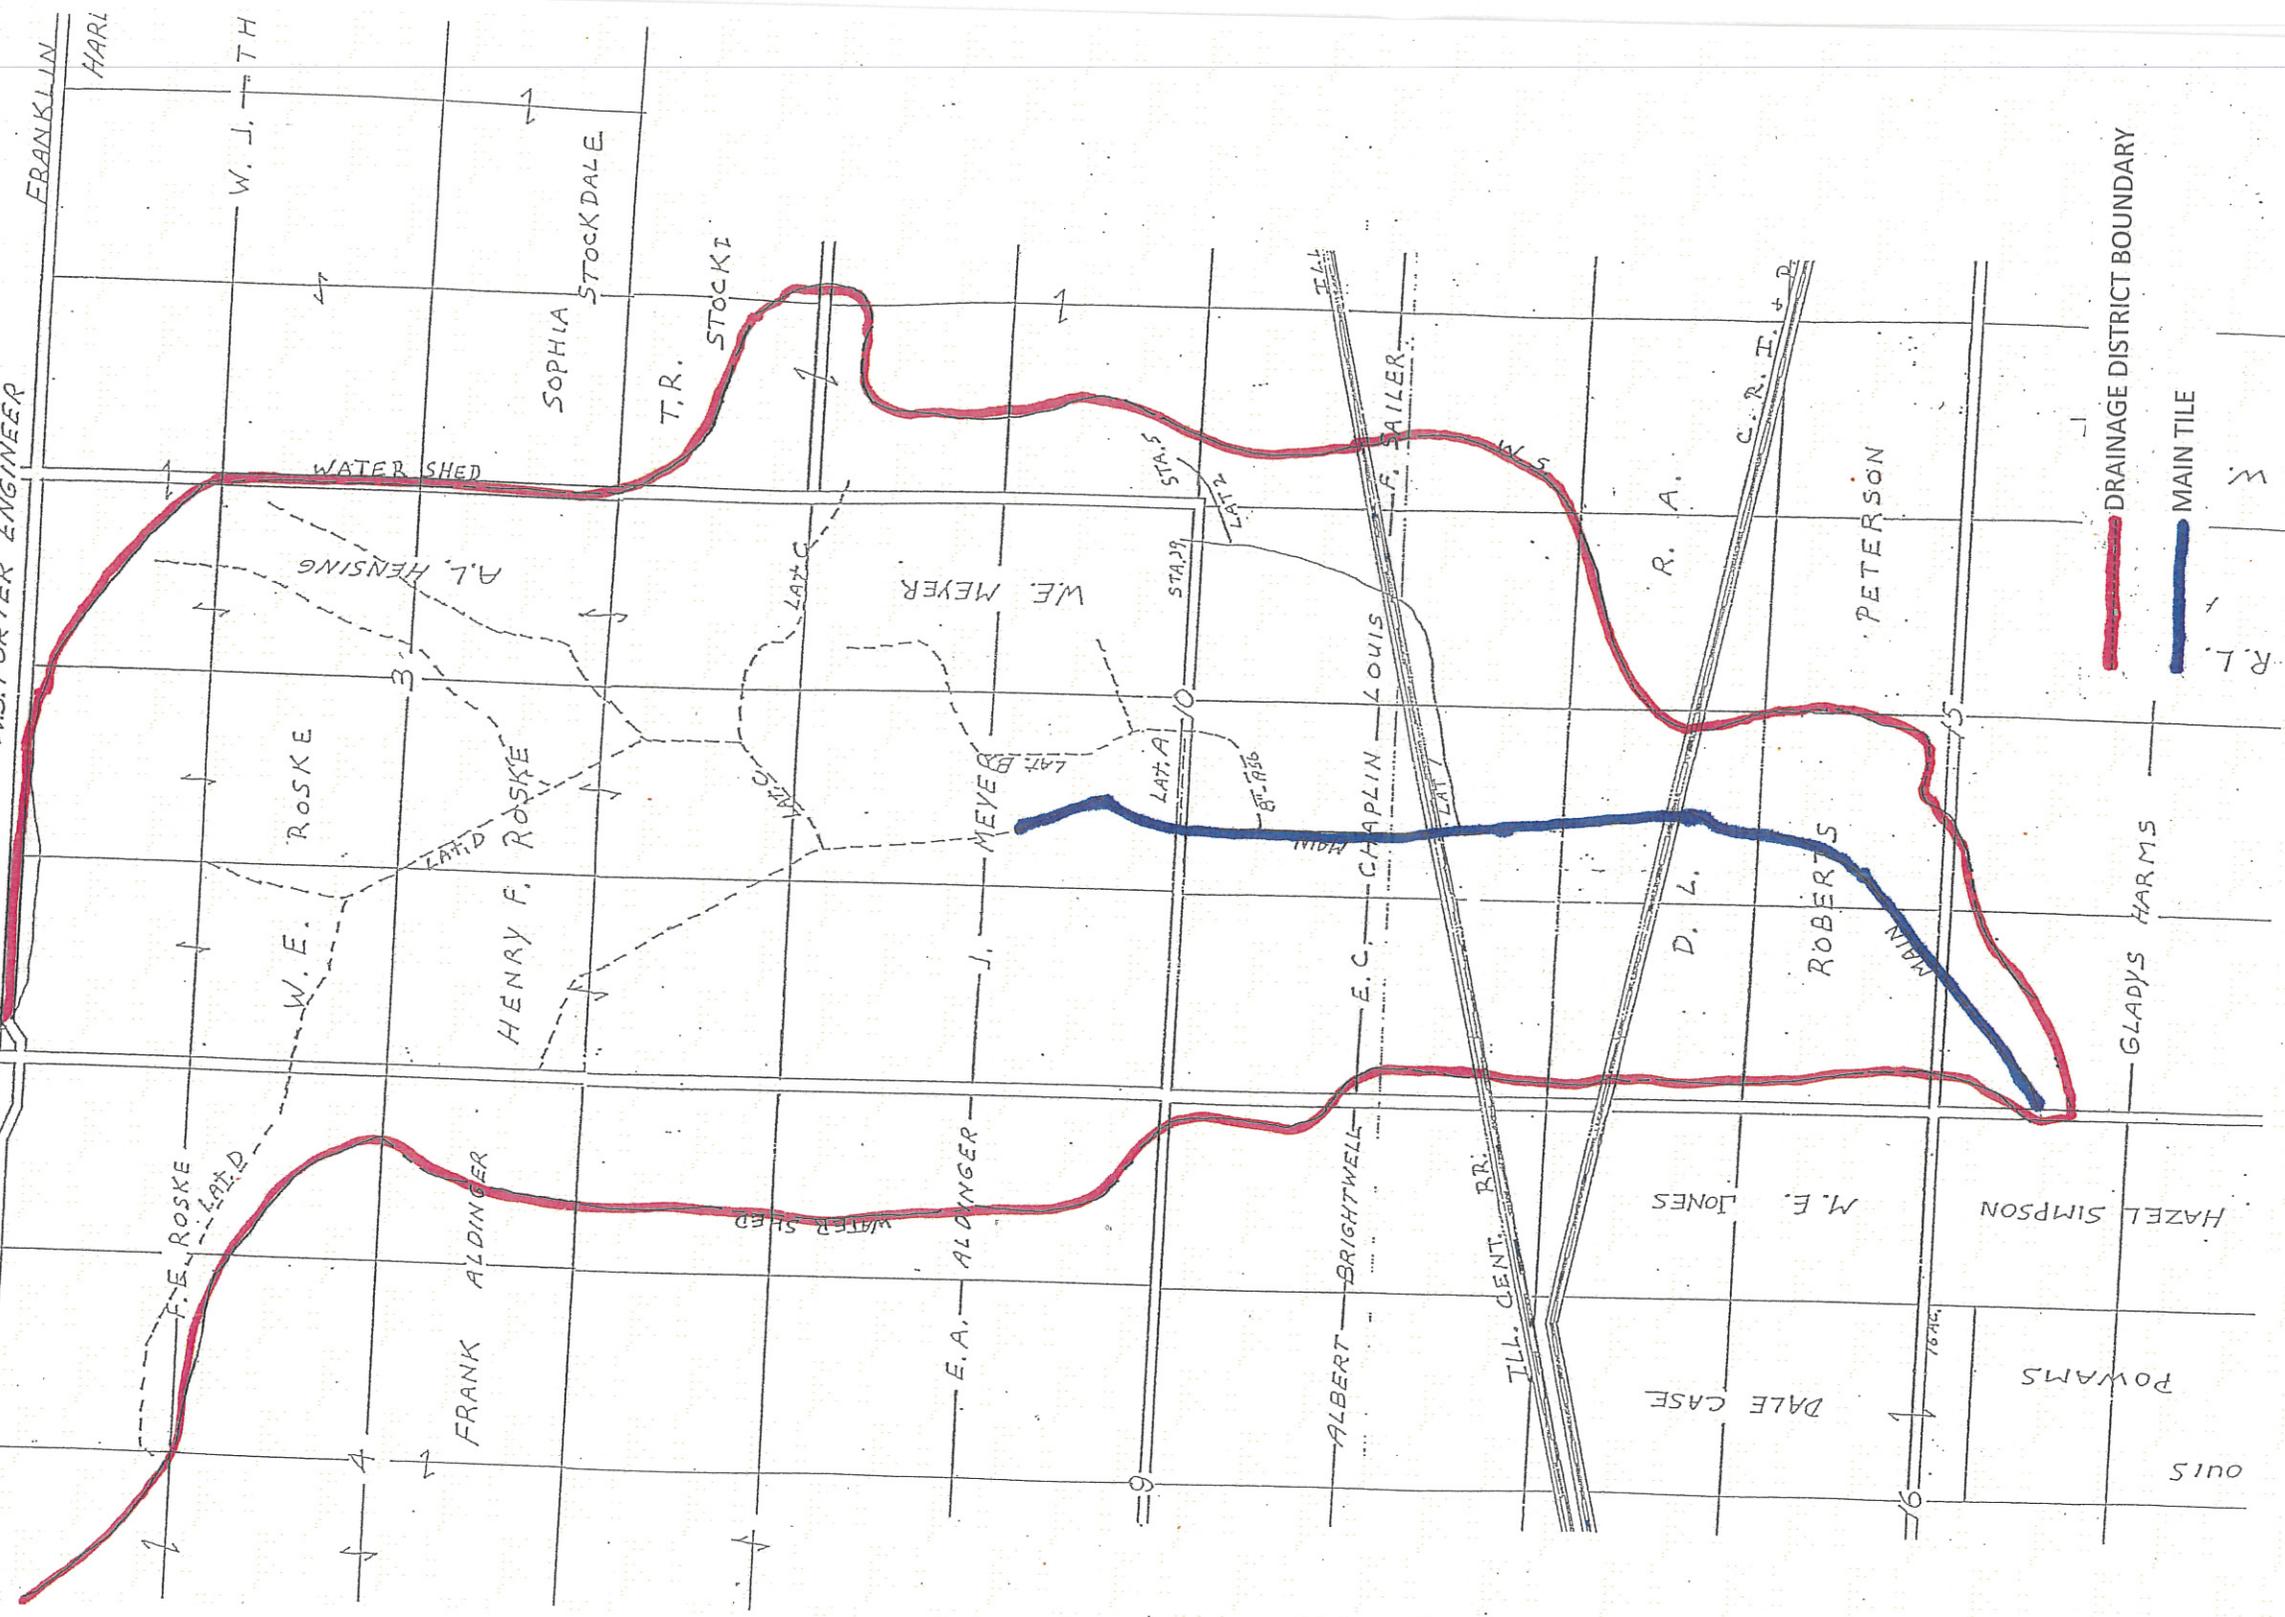
DRAINAGE DISTRICT NO. 98 OCT. 1917

2-1-02 THIS MAP WAS DETERMINED OFFICIAL MAP FOR D.D. 98.

CONTAINING ACRES SCALE 800' = 1"
W.S. PORTER ENGINEER

DRAINAGE DISTRICT BOUNDARY
 MAIN TILE
 R.L. 3
